Puerto Rico El Capitolio

SAN JUAN, PR

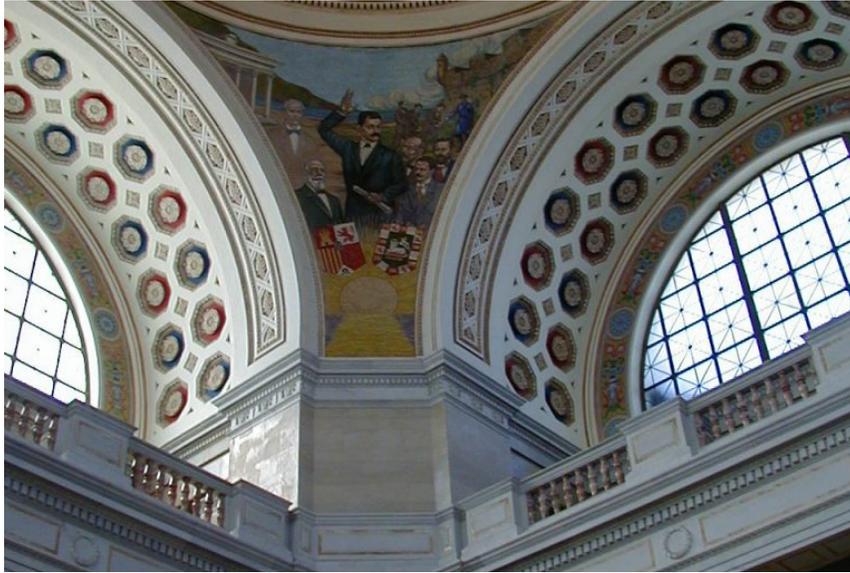
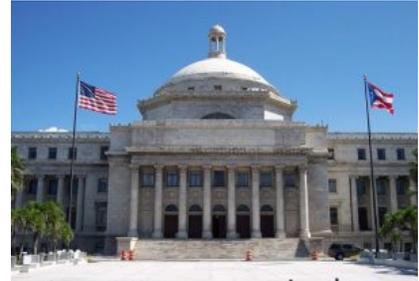
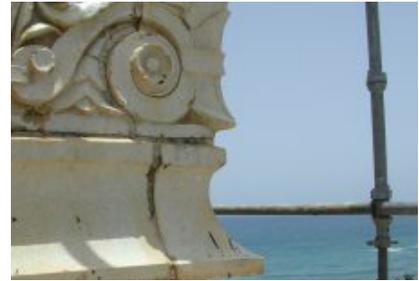
The investigation revealed several major problems which were all related to the ingress of large quantities of salt-laden moisture. It was recommended that all heavily damaged and collapsing areas of the cornice be dismantled and rebuilt using high quality matching new units from a well-established terra cotta manufacturer. In order to retain as much original material as possible, it was also recommended that the undamaged but unstable areas of terra cotta be stabilized in-situ using the Cintec anchoring system.
