Iwo Jima Monument Assessment

MARINE CORPS DEPOT, PARRIS ISLAND, SC

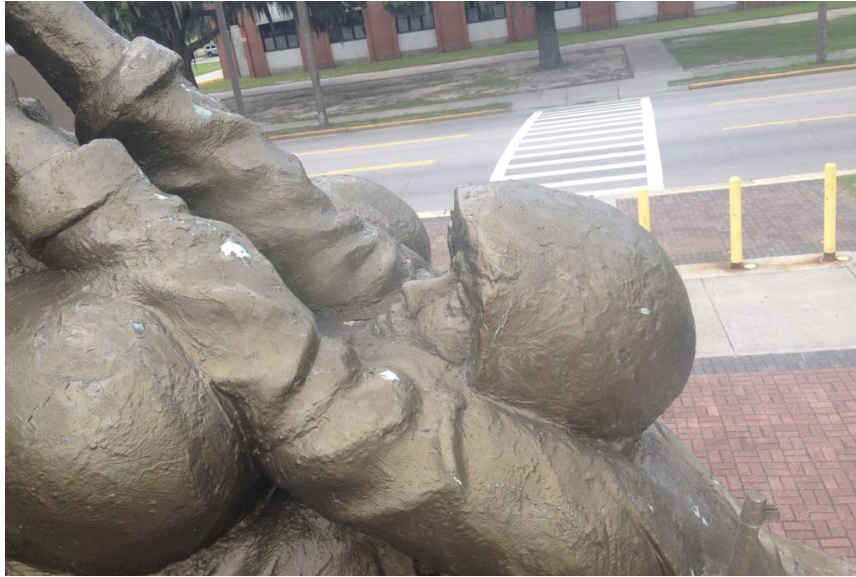
The monument is in poor condition due to a number of factors related to its material composition and construction methods. A previous conservation assessment established that the cast stone was deteriorating, and that the interior iron armature was likely in poor condition and contributing the failure of the cast stone. We were part of a team of conservators, engineers, and technicians that were contracted to perform an investigation of the armature and provide recommendations for treatment.

As a part of the investigation, a team of radiographers took x-rays of the entire monument. Conservators analyzed x-rays to map the network of iron reinforcement, and to locate areas of heavy corrosion and breaks in the iron. In efforts to document the entire sculpture's form, 3-D laser scanning was performed. These two technologies were used to gain a better understanding of the conditions and formulate a plan for conservation that would include the treatment of the armature and exterior shell in situ.
