The New York Public Library Statuary– Marble Deterioration & Conservation

Abstract

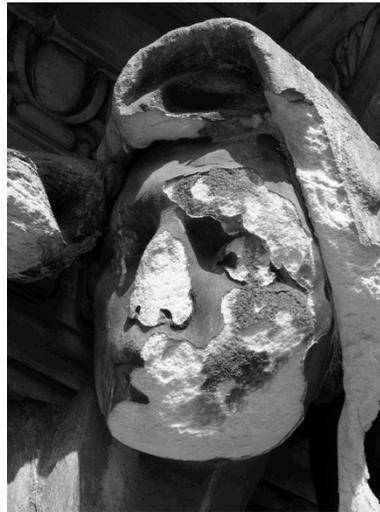
Figure 4 (above): Barnard pediment group detail showing extent of deterioration prior to treatment.
Figure 5 (below): Condition were noted on assessment drawings prior to treatment implementation.

The Barnard groups were the most severely compromised. Caked bird guano, black gypsum crusts, friable fissured stone, and major and minor losses were endemic. A substantial amount of detailed carved surfaces had been lost, leaving the complex compositions disfigured and illegible. Due to the extreme vulnerability of these surfaces it was decided to clean them with lasers, which was carried out by Giancarlo Calcagno using Nd:Yag Q-switched *Michelangelo* units by Quanta after an initial removal of loose soiling.

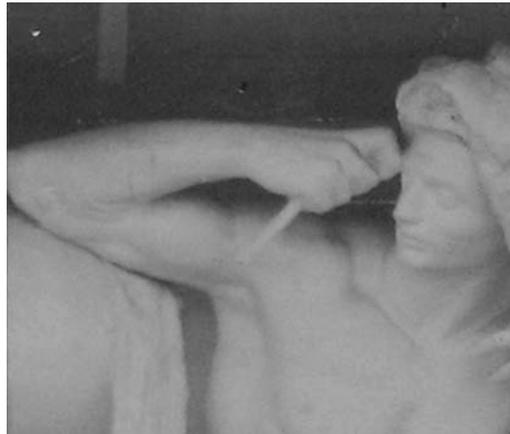
Figure 6 (above): Barnard Pediment Group Art in historic photo detail

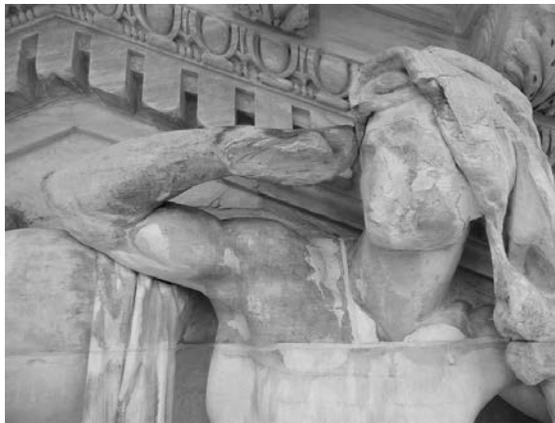
Figure 7 (below): Conditions of same figure after laser cleaning showing extent of erosion and loss.

Although laser cleaning removed all of the black gypsum crusts on the surface of the pediment sculptures, removal of the crusts revealed areas of yellowish-orange staining. In many areas, the staining extended beneath the surface of the stone, sometimes reaching depths of 6 or more inches. Attempts were made to mobilize and draw out this staining using various techniques including water poultice and Arte Mundit, a latex based poultice. Ultimately, Ammonium (Bi)Carbonate Gel Poultice manufactured by FTB Remmers applied repeatedly for 24 hour dwell periods was successful at removing the majority of the staining. Removal of biological growth, consolidation, and the application of the lime shelter coat were similar to those implemented for the Attic Figures. However, the condition of the pediment sculptures required additional treatments and a reexamination of the expectations of this project.

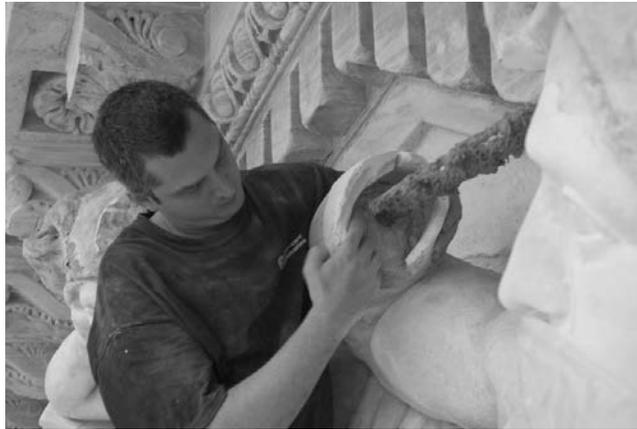
Figure 8 (above): Fitting replica casting at Barnard Pediment Group

For large areas of loss – either elements missing at the start of the project or areas where extreme deterioration require removal of extensive material – it was decided that new elements would be cast out of Lithos Arte. Dutchman repairs were ruled out largely because the weight of stone compared with Lithos Arte and because installation of new stone would require even more removal of original material. Casting of new elements was accomplished through a specially designed mold making and installation process based on the principle that cured or partially cured Lithos Arte successfully bonds to wet Lithos Arte.

Before casting, all stone adjacent to treatment areas was protected with 3 mil plastic sheeting. Additionally, cyclododecane (dissolved to a 30% solution in Naphtha) was brush applied to all treatment surfaces. Once re-crystallized, cyclododecane provides a protective barrier which lasts for several months until eventually sublimating into gas form. For elements which required removal due to instability beyond repair, molds were then taken using Resilpom putty followed by a burlap and plaster mother-mold. Missing elements were first sculpted *in situ* out of oil-based clay; the mold was then taken of the newly created element. Where necessary, molds were created in sections to allow for ease of installation of the cast elements. Once cured, molds were removed and used to cast the elements out of Lithos Arte at an average of 1” thickness. Fiberglass armatures were textured with epoxy and installed at areas to receive cast elements; in some cases, preliminary forms were created on the armatures using Lithos Arte. Cast elements were then installed, using wet Lithos Arte to fill any voids and secure the cast pieces to the armatures.

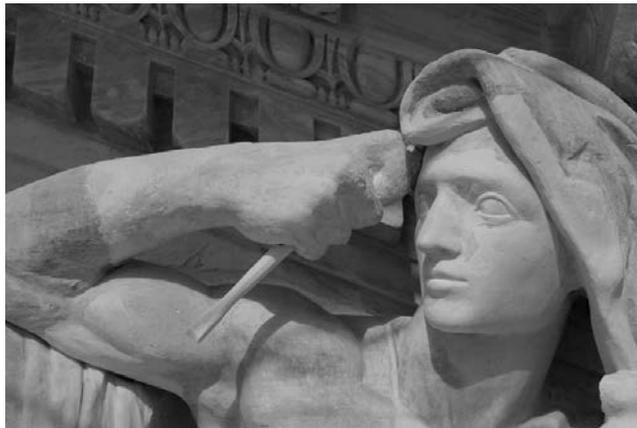
Figure 9 (below): Same figure after treatment.

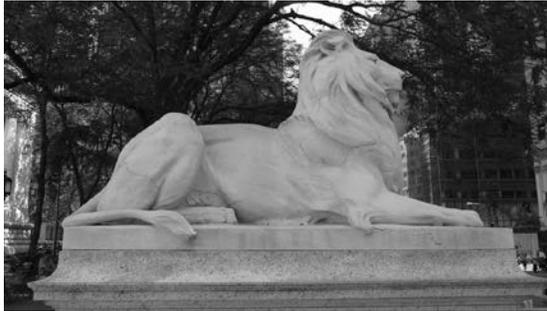
Figure 10; One of the Edward Clark Potter Lions.

At the completion of the main restoration scope, maintenance of the two iconic Tennessee marble lions was performed by CSI. They had been treated and maintained several times over the last decade and were in generally good condition. Nevertheless, localized areas of gypsum crust in areas protected from water run off,

overall soiling and biological growth existed. Work, including detergent washing, water misting, steam cleaning, biocidal treatments and injection fills generally followed that detailed above with the following modifications. Triton X-100 3% solution was used for detergent cleaning and Presto gel was selectively used to reduce tenacious black biota found on skyward facing areas after treatment with D/2.

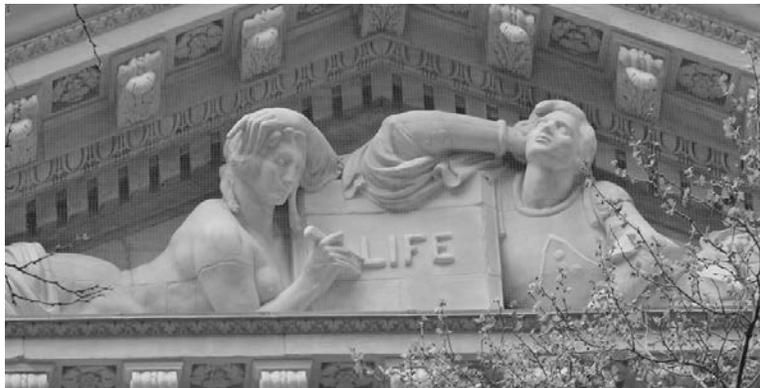
Figure 11; Barnard pediment group *Life* after treatment
