<p>CONSERVATION SOLUTIONS inc ART • ARCHITECTURE • ARTIFACTS</p>	
<p>FRENCH GILDED FOUNTAIN ASSESSMENT</p>	
<p>HILLWOOD MUSEUM &amp; GARDENS</p>	
<p>DATE: 5/10/17 DRAWN BY: mjr</p>	
<p><span style="color: magenta;">■</span> MARBLE</p>	
<p><span style="color: gold;">■</span> GILDED LEAD</p>	
<p><span style="color: red;">■</span> BRICK</p>	
<p><span style="color: blue;">■</span> TILE</p>

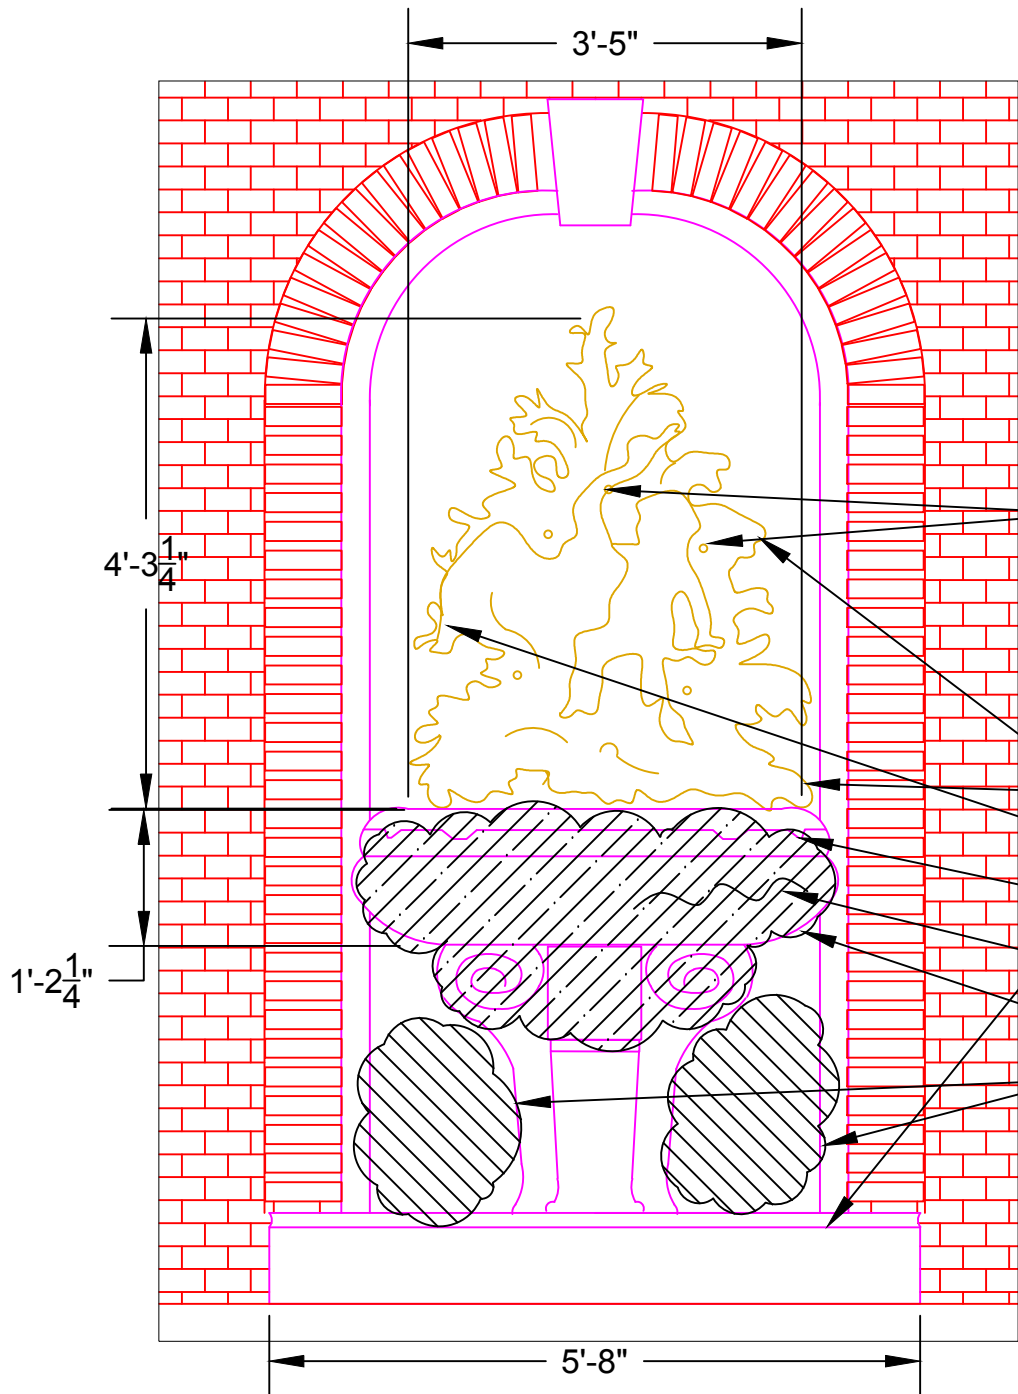
ELEVATION

APPOX. 2" CLEARANCE  
BEHIND SCULPTURE

GILDING FAILED 100%  
ON SCULPTURE

DEFORMATION

OPEN JOINT

EROSION & LOSS

CRACK

BLACK STAINING & CRUST

YELLOW STAINS & SCALE

BIOLOGICAL GROWTH  
THROUGHOUT  
BASIN, STAND & COPING

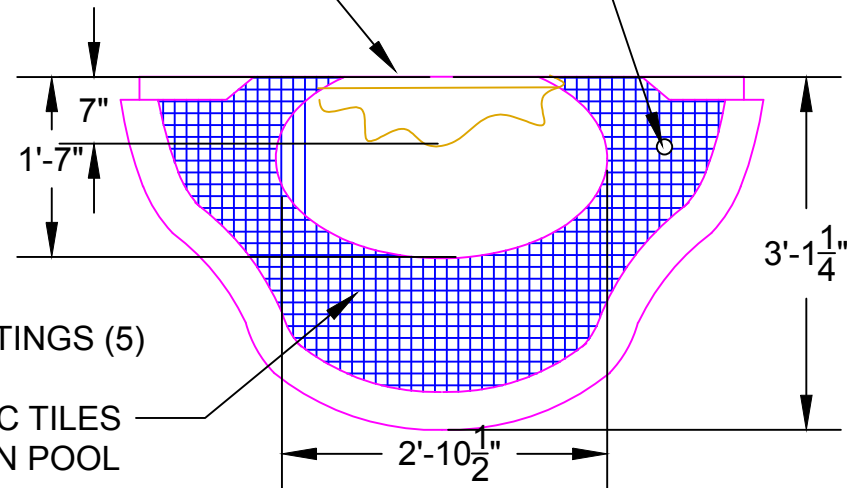
PLAN

MOSAIC TILES  
IN POOL
