Restoration Quarterly

Fall 2000

Carton-Pierre: a Case Study

Ornamental Ceiling Restoration at the Illinois State Capitol

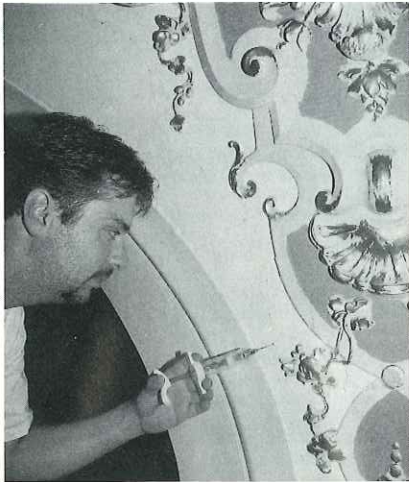
applied ornament: water damage, delamination from the substrate and between layers, detachment of ornament, and substantial cracking. The most interesting and unusual problem affecting the plaster is a phenomenon similar to that of spalling in brick faces. Expansion around shiny black particles in the brown coat forces finish plaster on the surface to dislodge, and can be surprisingly destructive in lifting or delaminating ornament attached to either the finish or brown coat. When the expelled plaster is removed, a black inclusion is visible at the center of the mass. This type of damage was widespread in the Senate chamber, which retains much original plaster, but not in the House, where the flat plaster was replaced in the 20th century.

Plaster doctor Ed Magee consolidates hairline cracks in flat plaster and delaminating carton-pierre ornament at the Illinois State Capitol.

- Consolidate by drilling and injecting acrylic dispersions to secure delaminating flat plaster and ornament.
- Mechanically secure plaster ornament using stainless steel fasteners, some set in epoxy.
- Replicate missing or damaged ornament in our plaster shop to match the appearance of the originals.
- Repair cracks using standard methods of channelling and filling.
- Repair spalls in flat plaster caused by oxide jacking.
- Coat flat plaster with liquid polymer coating with a fiberglass mesh interleaf, and skim coat. This creates a tough, impervious skin which will serve as a smooth receptive surface for the new decorative painting. It is a longer-lasting system than the canvas previously used on the ceiling.
