Proceedings of
Preserving US Military Heritage: World War II to the Cold War
Fredericksburg, Texas, June 4-6, 2019

Conservation of the Iwo Jima Monument Parris Island for the United States Marine Corps

Claudia G. Chemello and Paul Mardikian, Terra Mare Conservation, LLC, Charleston, South Carolina; and Joseph Sembrat and Mark J. Rabinowitz, Evergreene Architectural Arts, Inc., District Heights, Maryland

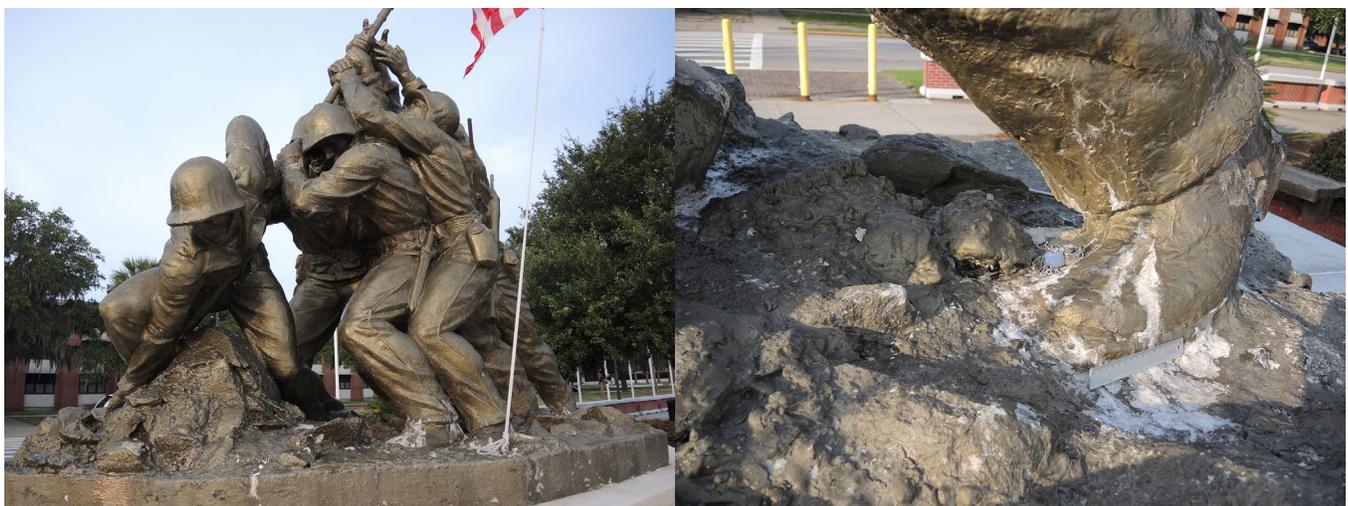
As discussed above, either immediately after fabrication or soon after completion, the sculpture received a primer and finish coat of paint. Shortly after exposure to the environment of Parris Island, the sculpture began to develop cracks and fissures allowing pathways for water to penetrate the concrete, saturating the mortar/clay core (see Figure 2). The surface was subsequently coated with thicker and less permeable coatings in an attempt to fill the cracks and stop the deterioration. The cracks were filled with various patching materials including polyurethane foam, polyester resin, Portland cement, wood, and caulk. Unfortunately, despite repeated maintenance and repainting campaigns, the deterioration continued owing to excessive water intrusion. The internal clay was continuously wet in the high humidity at the site (often above 75% RH) and unable to completely dry out, and the constant entry of water caused leaching of mortar onto the surface. The rebar armature was severely compromised due to severe corrosion. Thermal stress due to continued cycles of heating/cooling and wetting/drying also contributed to the cracking. In general, deterioration was more severe on the lower part of the sculpture owing to gravity, particularly on the lower torsos, legs and feet, but was also prominent on the hands around the flagpole and on all skyward-facing surfaces.

Figure 2. The monument before treatment showing failed coatings and surface cracking.

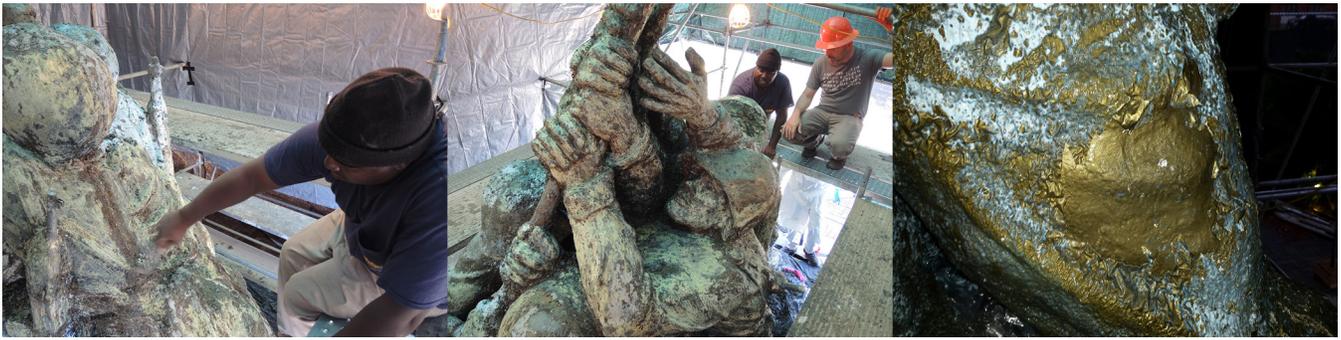
Figure 3. During coating removal.

Eleven layers of paint were removed with Sea to Sky SPC-202 water-based paint remover. The paint remover was applied to the surface and covered in plastic film overnight to soften the paint, as seen in Figure 3. The softened coatings were then removed mechanically with plastic scrapers and the sculpture was thoroughly rinsed with water to remove residues. This sequence was repeated several times as needed to soften and remove the multiple paint layers. After paint removal, a thick impermeable coating still remained on the surface. This was originally thought to be the surface of the concrete, as it was green in color. Testing revealed that this was actually a thick combination of polyester and epoxy materials, almost completely covering the surface. In places, this coating was sculpted to conform to the surrounding surface, and clearly had been applied in an attempt to

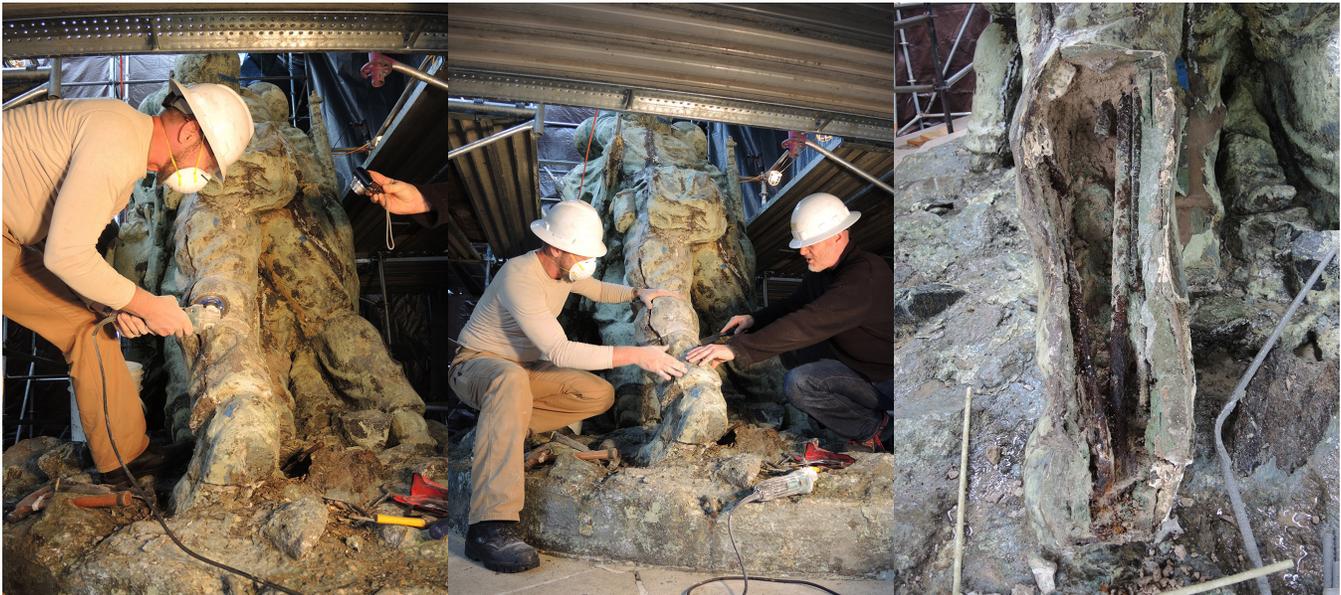
5). Registration marks were made on the sections that were removed so that they could be reattached in their exact locations at a later date. These processes were documented in field drawings and photographs. Once sections of the outer shell were removed and the internal clay exposed, these areas were excavated using pneumatic chisels and other hand tools, and/or pressurized water at 3,000 psi with rotating nozzles. In some areas such as the left foot of Hayes, a particularly problematic area, water and loose clay core flowed out of the cavity after removing the concrete shell as excess moisture was retained inside the cavity. The clay core in this area was completely saturated.

Figure 5. Opening up the sculpture for restoration beginning with the left leg of Hayes (left and middle), and after removal of clay core and corroded rebar (right).

The internal core and rebar were accessed by cutting through the concrete outer shell layers using a diamond blade fitted to 4 ½" and 7" electric grinders (see Figure

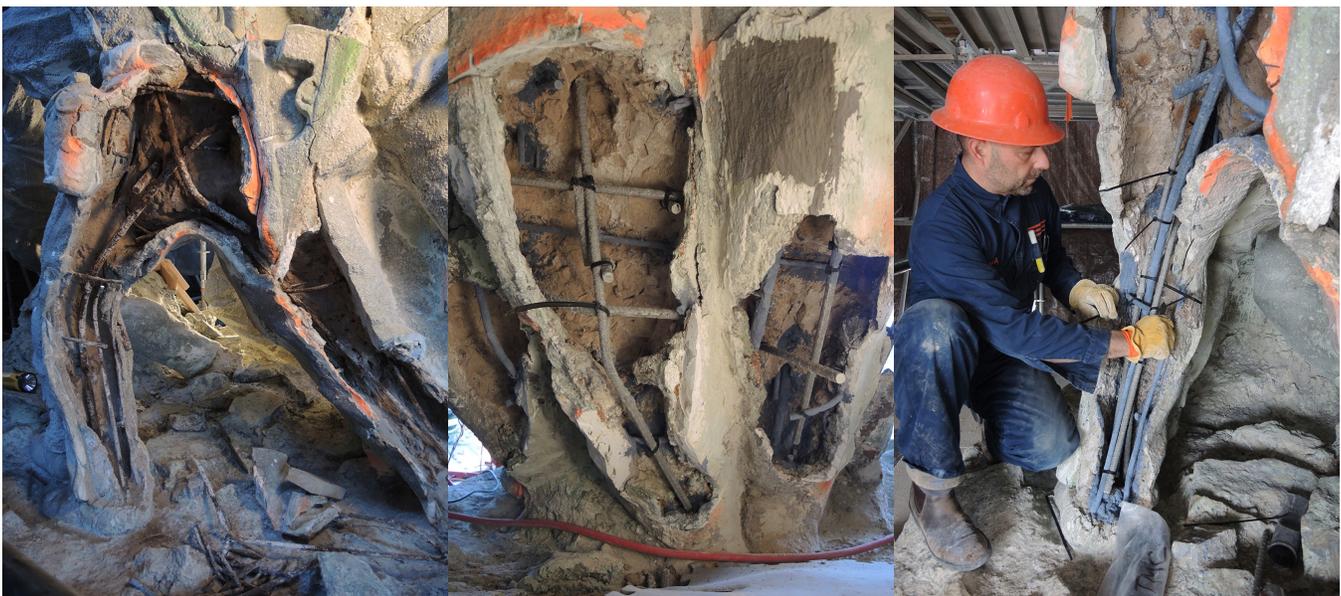
Corroded sections of steel rebar were accessible once the clay core was removed. Moderate to severe corrosion was visible on the majority of the accessible rebar. In parts of the sculpture that were particularly wet or damp, such as the feet of Hayes and Sousley, and the lower legs of Hayes, Sousley, Schultz, Strank and Gagnon, rebar showed extreme levels of corrosion with more than 50% of the bar thickness reduced (# 5/0.625 inch diameter and #8/1 inch diameter bars), as seen in Figure 6 at left. Rebar that were embedded in the wall of the concrete shell were often completely disintegrated. Some sections of rebar had become detached due to corrosion and readily fell out on excavation.

Figure 6. Treatment and attachment of new rebar inside Schultz at left and right and Sousley at center.

Corroded rebar armature was removed with a metal cutting wheel and replaced with new fiberglass rebar of the same approximate diameter, either # 3/0.375 inch diameter, # 4/0.500 inch diameter or # 5/0.625 inch diameter. The new rebar were lapped onto existing rebar with nylon zip ties, see Figure 6 on middle and right images. Where rebar were in direct contact with the concrete shell, they were secured to the shell with Sikadur®-31 (Sika) structural epoxy. Lapping extended to approximately 12 inches in each direction where feasible. Where possible, the rebar were either inserted into predrilled holes into an adjacent unexcavated clay core, or holes were drilled through to an adjacent excavated area and the rebar from one area joined to the rebar from the adjacent area for maximum strength and continuity. All replaced rebar were assessed by project structural engineer Craig Bennett from BPE during two site visits, and by photographs, to ensure that the new rebar were correctly attached to existing rebar and structurally sound.

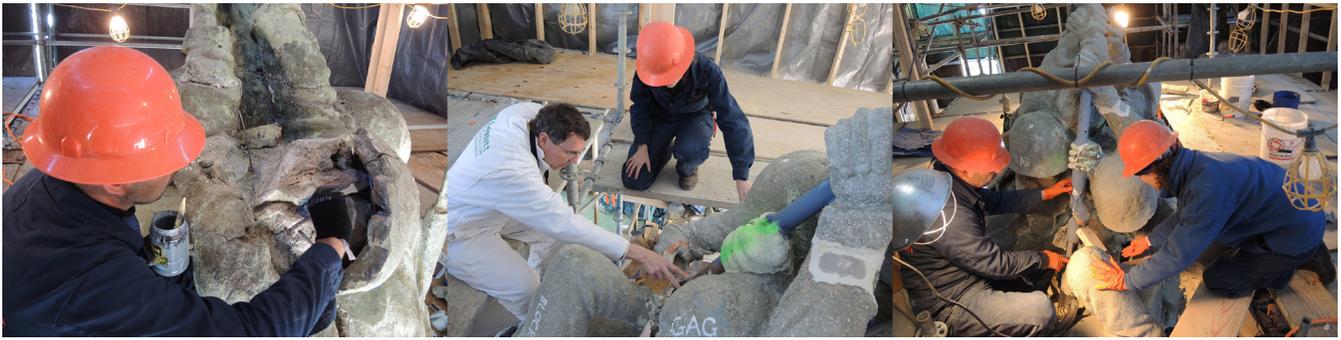
The base of the flagpole was an area of major concern due to the stress from constant movement of the pole (see Figure 7 middle and right image). After removal of the lower set of hands belonging to Sousley and Gagnon, the base of the pole was found to be extremely corroded and poorly secured to the sculpture. The pole is attached into the lower back of Block and is then connected to a much smaller diameter length of rebar which continues down into Block's body. A decision was made to cut the pole about 10 cm (3.94 inches) from the bottom, blast the pole with crushed glass and apply two coats of Mapefer 1K. The interior of the pole was also cleaned out and wire brushed as far as possible to remove loose corrosion products. After thorough drying of the coating, the base of the pole was reattached to the sculpture with five pieces of # 3 fiberglass rebar approximately two feet in length extending into the pole and into Block's back. The new rebars were secured in place with Sikadur[®]-31 epoxy. The hands of Sousley and Gagnon were reattached with Sikadur[®]-31 epoxy and remodeled with Planitop XS (Mapei).

Figure 7. Coating of rebar at left and repair of the flagpole (middle and right).

ed to less than 50% of the bar thickness. These rebar were mechanically cleaned with steel brushes and small pneumatic chisels to remove loose, flaky corrosion and adherent mortar. Once clean, the rebar were blasted with fine crushed glass to a near-white level to remove corrosion products. After blasting, the rebar were coated with two coats of Mapefer 1K (Mapei) corrosion inhibiting mortar, applied by brush as seen in Figure 7 at left.

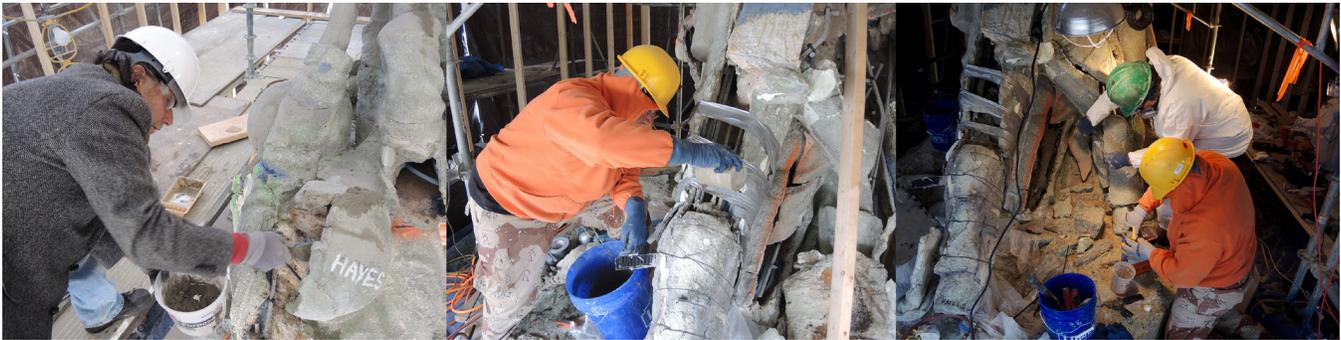
Figure 8. Remodeling of the helmet of Hayes (left) and rebuilding excavated sections of Hayes' legs (middle and right).

After the clay core had been removed in targeted locations, and the rebar treated or replaced, the voids within the sculpture where the clay core had been removed were refilled. The rebar were first encased in Planitop XS to a minimum depth of 1" or entirely encased in narrow sections such as at ankles. Larger voids were then packed with a concrete mixture consisting of one part Type "N" cement, three parts sand, and three parts pea gravel. The concrete was either poured into the voids formed by the re-attached fragments or built up in several lifts to recreate missing sections up to 1" below the finish form (see Figure 8). After initial set, these areas were sculptured with Planitop XS as described below.

Some sections proved to be too friable and deteriorated to reinstall. These areas were built up using Planitop XS following original profiles and contours. The material was applied to a minimum 1" thickness atop the fills, allowed to stiffen during an initial set, and then leveled back to the finished forms. If multiple lifts were required, they were applied after a minimum of eight hours cure of the previous lift. The rifle of Schultz and the dagger of Hayes were also remodeled with Planitop XS due to loss of original material.

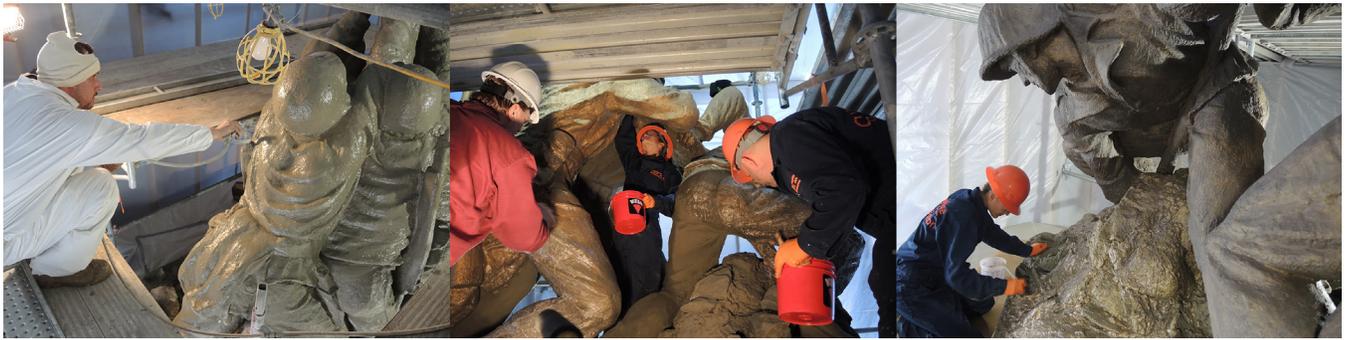
Figure 9. Application of the final coatings, the base coat (left) and the metallic finish (middle and right).

One base coat of Keim Soldalit Grob was applied by airless sprayer, (see Figure 9 left image). Grob is a textured silicate filler for base coats within the Soldalit system. The Grob was followed by one coat of Keim Soldalit color # 15198, applied by airless sprayer. The base coats were applied by UHP. The final colored top coat was composed of one layer of Keim Design Lasur metallic finish Color # 1001 & # 1003, 50/50, applied by brush followed by two layers of Keim Design Lasur, color # 14045 (see Figure 9 and 10). Lasur is a pigmented

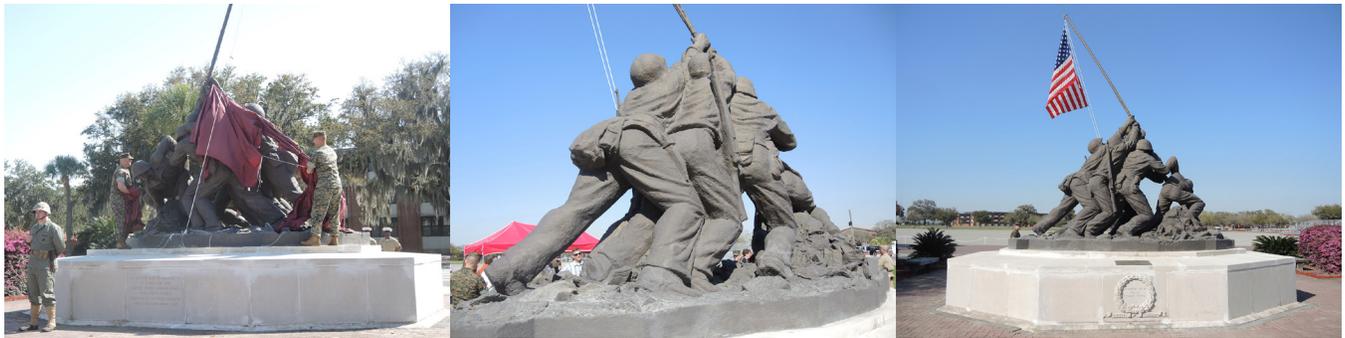
Figure 10. The Iwo Jima Monument after treatment.
