House of the Temple Laylight Protection

WASHINGTON, DC

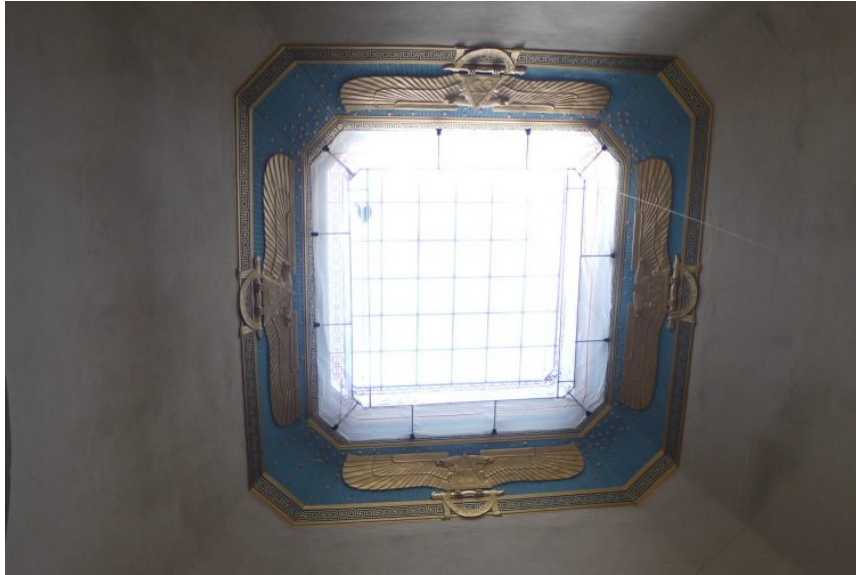
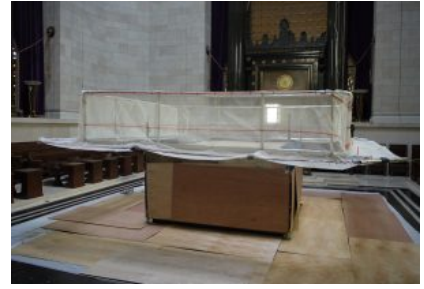
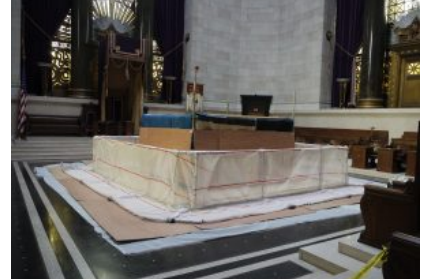
Among the other effects of the unusual earthquake in 2011 to this landmark John Russel Pope building in Washington DC, the decorative plaster around the laylight at the top of the Guastavino dome was dislodged and weakened. Fragments began falling almost a year after the event, presenting a life/safety issue. Nearly 90 feet above the chamber floor, the virtually inaccessible site required some protection and stabilization until the interior could be scaffolded during an upcoming planned major rehabilitation for the building's one hundredth anniversary.

Our conservators studied the conditions, devised a netting frame that could be assembled on the ground and hoisted into place off the unusual truss skylight above the dome. After engineering review, the frame was built and installed in 2013.
