18th Century Carshalton Iron Gates Restoration—The Planting Fields Estate

OYSTER BAY, NY

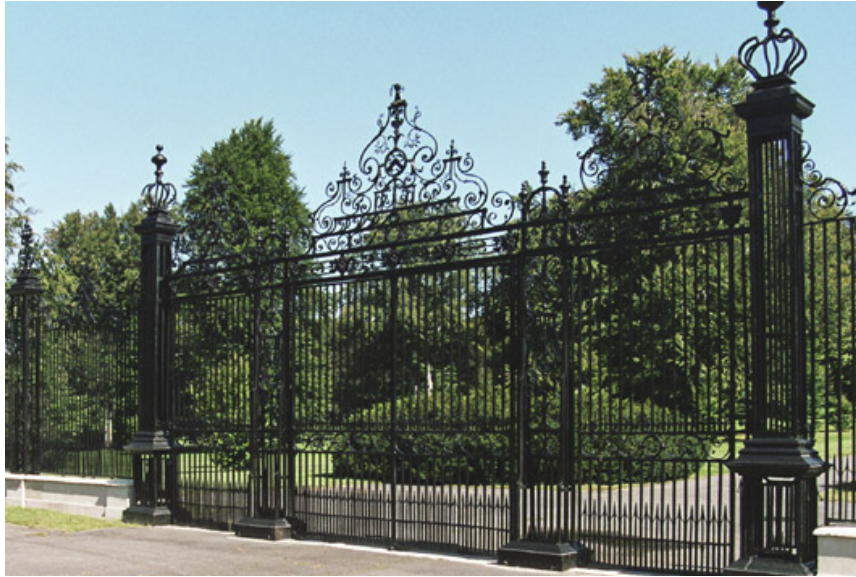
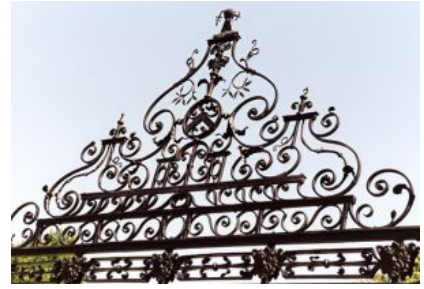
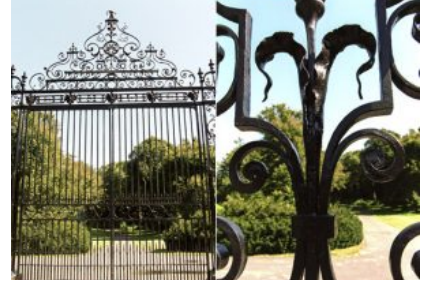
Each element was stripped of existing coatings and assessed for damages and necessary repairs. Most losses were associated with entrapped water which led to rust formation. Work was divided into unit replacements, in-kind repairs and synthetic fills. Skilled craftsmen repaired losses in keeping with the original design and assembly details while removing water catch points.

We completed the restoration of the Carshalton Gates between 2003 and 2004. The gates were documented before removal from site. Careful measurements were taken to assure that the gates could be reinstalled after restoration. A paint analysis was done prior to treatment to determine the original paint color and scheme.

Upon completion of the restoration, the gates were again cleaned and metallized before being coated with a high performance paint system. They were transported to the site and installed atop their restored stonework.
