19th Century Brick, Paint and Plaster Investigation—Flag House and Star-Spangled Banner Museum

BALTIMORE, MD

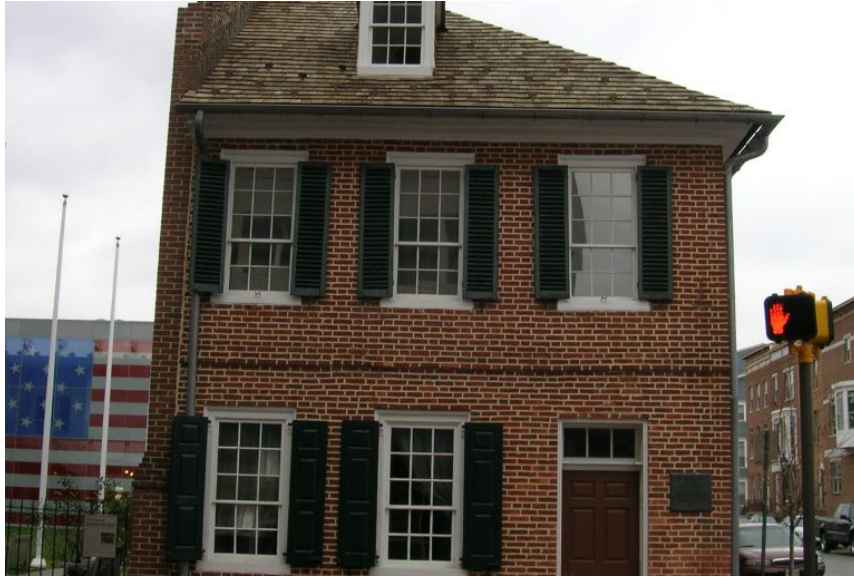
The building was exhibiting widespread failure of the interior paint and plaster finishes on the perimeter walls, up to a height of three feet above grade, suggesting significant rising damp. The paint was splitting and peeling, and the plaster beneath it was blooming with salt crystals (efflorescence). Wood baseboards in the hallway had rotted and already had been removed. Troubling piles of salt and disintegrated stone particles had accumulated along the rubble stone foundation.

We were contracted to assess the current conditions and determine the likely causes of the failures and possible solutions. We performed a thorough survey of the building and site. Several openings were made to gain insight into hidden structural conditions. Brick porosity and moisture content were measured in-situ, and samples of mortar, salts, and paint were removed for off-site testing. We developed a comprehensive treatment plan with recommendations for correcting drainage, installing means of waterproofing, and for dehumidification and salt removal within the house. Recommendations were tailored and prioritized based on the most immediate needs and budget of the client.
