7 Gracie Square Doors

NEW YORK, NY

EverGreene was engaged by the cooperative board in 2010 to perform a conditions assessment and materials analysis on the entrance doors. The purpose of the assessment was to understand the original artistic intent, materials usage, and manufacturing methodologies, as well as to identify means, mechanisms, and locations of deterioration. EverGreene based cost estimates and repair recommendations off information from the analysis.

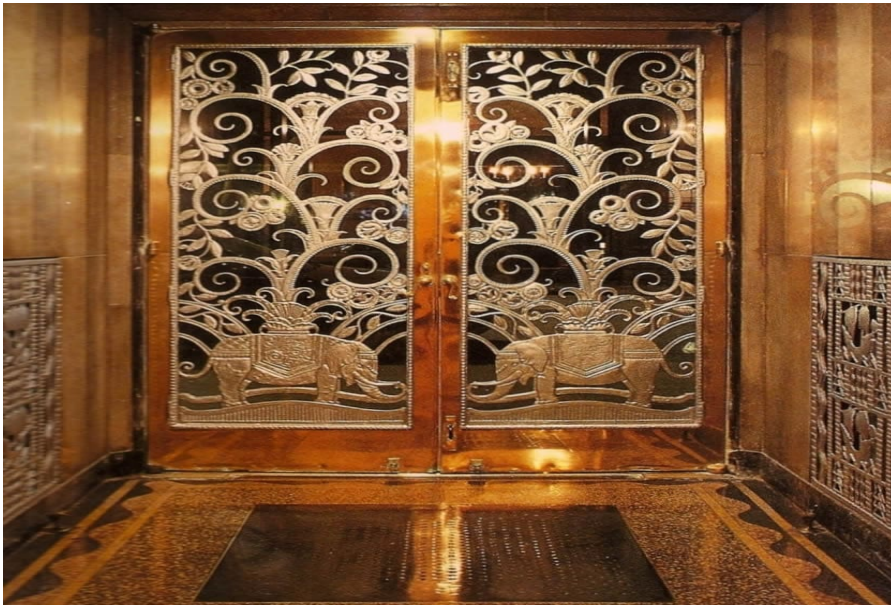
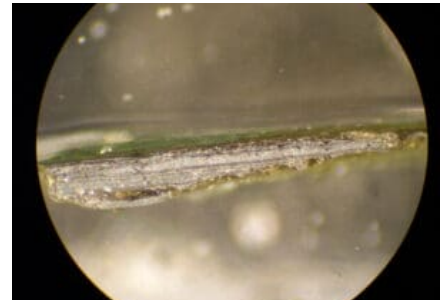
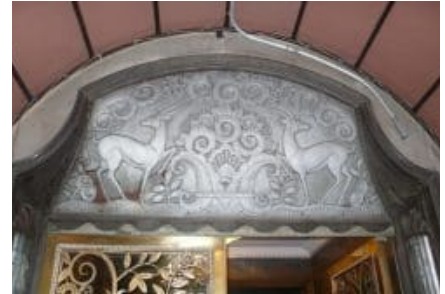
A significant and unique element of the design was the set of entrance doors, which are an example of high end Art Deco metalwork. Artisans from the firm of Edgar Brandt produced a masterpiece of technology and dazzling visual effects; they integrated sophisticated decorative finish schemes—including metalizing, plating, and textural treatments—and used an astonishing array of metals. Over time, the decorative metalwork had become deteriorated as a result of age and improper maintenance.

As part of the work, EverGreene employed hand-held X-ray fluorescence (XRF) to identify the metals used in the fabrication of the doors. The base metals were determined to include cast iron, sheet brass, cast bronze, and aluminum. Remnants of original finishes were also identified, though these were intermittent and more difficult to characterize. One notable finding was that the cast iron gazelle panel adorning the door head was cadmium plated—a rare metal seldom used in decorative architectural applications of this type.

EverGreene worked closely with a cast iron restoration contractor to develop a comprehensive scope of work and restoration approach that would return the doorway to its original appearance while restoring full operational functionality.
