## Alexander Hamilton Sculpture

COLUMBIA UNIVERSITY, NEW YORK, NY

We were contracted by Columbia University to perform conservation treatment on the Alexander Hamilton statue in front of Hamilton Hall. Sculpted by William Ordway Partridge and erected in 1908 the bronze elements and limestone base required cleaning and conservation treatment.

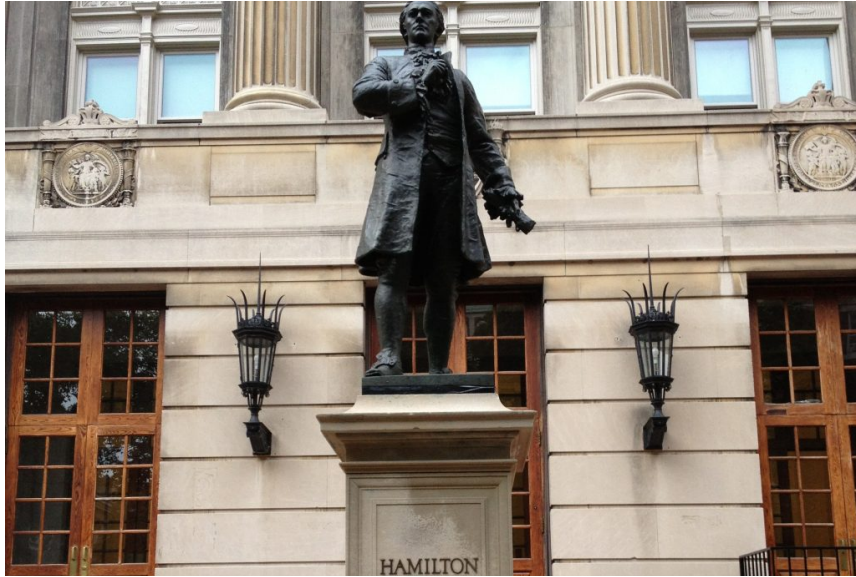
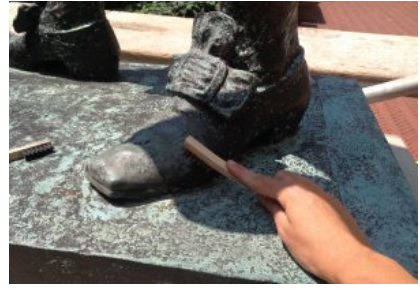
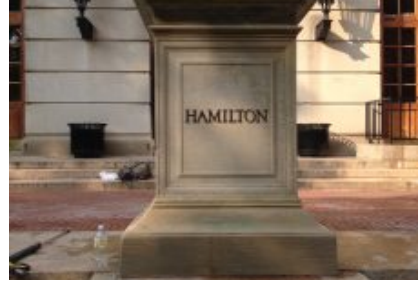
The bronze elements had experienced weathering resulting in protective wax failure, green and black corrosion. Once these elements were cleaned of failed wax and loose corrosion the bronze was spot-patinated with dilute solutions of sulfurated potash (liver of sulfur) and ammonium sulfide to create a consistent, historically accurate patina. New coatings of sacrificial wax were applied and polished. The failed joint between the bronze figure and stone base was packed with lead.

The limestone base exhibited general soiling, joint failure, areas of copper staining, and gypsum crust accumulation. The base was cleaned of soiling with a non-ionic detergent and clean water. Chemical poulticing helped to reduce the copper staining and the gypsum crust was manually removed. The joints were raked and repointed. A written plan for continued maintenance was created to help reduce future deterioration and to increase the longevity of the conservation treatment, thereby reducing future costly conservation treatments.
