Ariel Rios Federal Building

WASHINGTON, DC

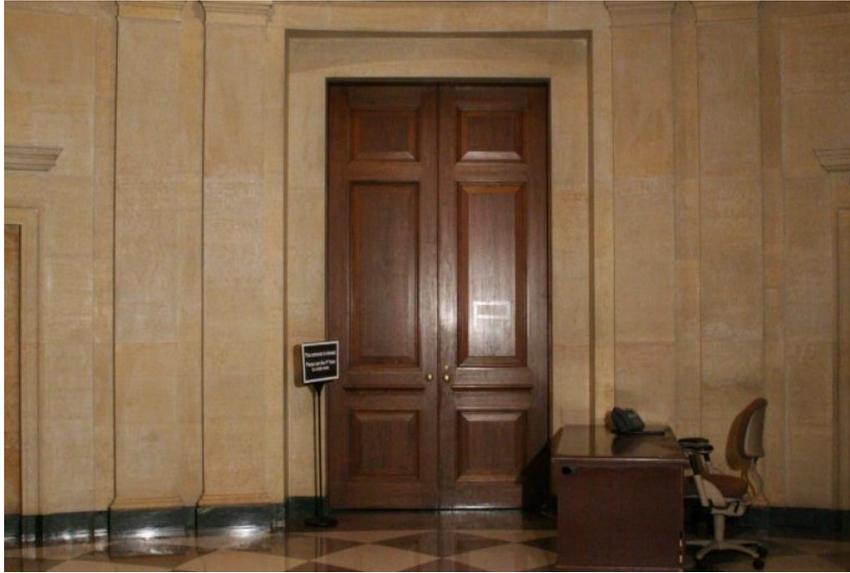
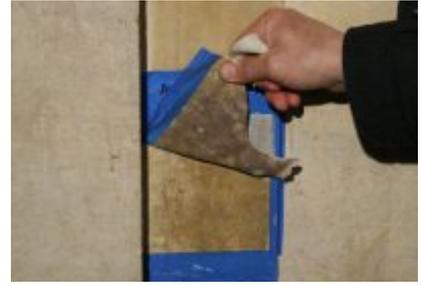
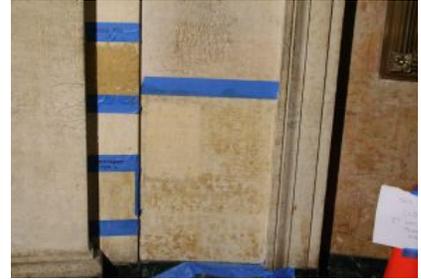
The stone exhibited evidence of past treatments, including a whitish haze and prominent drips and streaks, which disrupted the original polished finish. Stones have been worn, fractured, and soiled from repeated contact in predictable areas where people tend to linger. Floor wax has splashed up the wall, trapping dark soiling. Various tapes, used to hang temporary signage in the halls, have left tenacious adhesive residue and stains on the stone.

We were contracted to conduct a condition assessment of the lobbies, as well as perform on-site cleaning tests directed towards developing a specific treatment plan. Cleaning tests initially targeted specific conditions to better understand the nature of the phenomenon. We then directed tests to develop the most efficient treatment plan, in which the fewest products or techniques could be used to address the greatest variety of conditions. Testing also accounted for the practical variables of working in a federal building. This included using products that are low toxicity, maintaining a secure workplace, and staging work so that it would be of minimal disruption to the building.
