Baltimore City Hall

BALTIMORE, MD

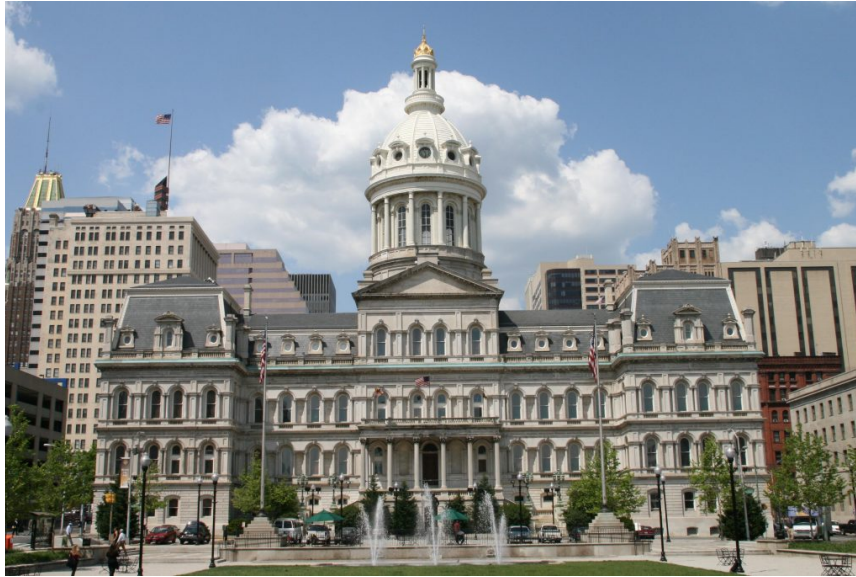
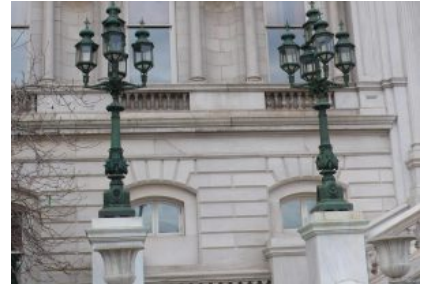
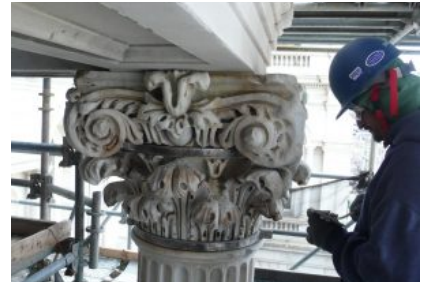
As part of an overall restoration of the façade, we were contracted to restore the lanterns and capitals of the columns. Numerous small castings and elements had been lost from the ornate lanterns, glass was missing or been replaced with plain glass (rather than beveled), and the surfaces had acquired the typical appearance of under-maintained bronze. The capitals had suffered from advanced "sugaring" and developed structural cracks that represented life-safety concerns.

Our conservators removed the lanterns for treatment in an art foundry. Missing elements were recreated, new beveled glass was cut and installed, and the lighting was up-graded. All surfaces were cleaned and coated with a conservation grade hot-applied wax. The capitals were cleaned with water misting and micro air abrasion. Stainless steel dowels were installed to stabilize cracks and potentially fragile foliate pendants were wired to the body of the capitals to avoid later losses. Cracks and losses were filled with lime-based grout and mortar.
