Statuary Walk Columns

VIZCAYA MUSEUM AND GARDENS, MIAMI, FL

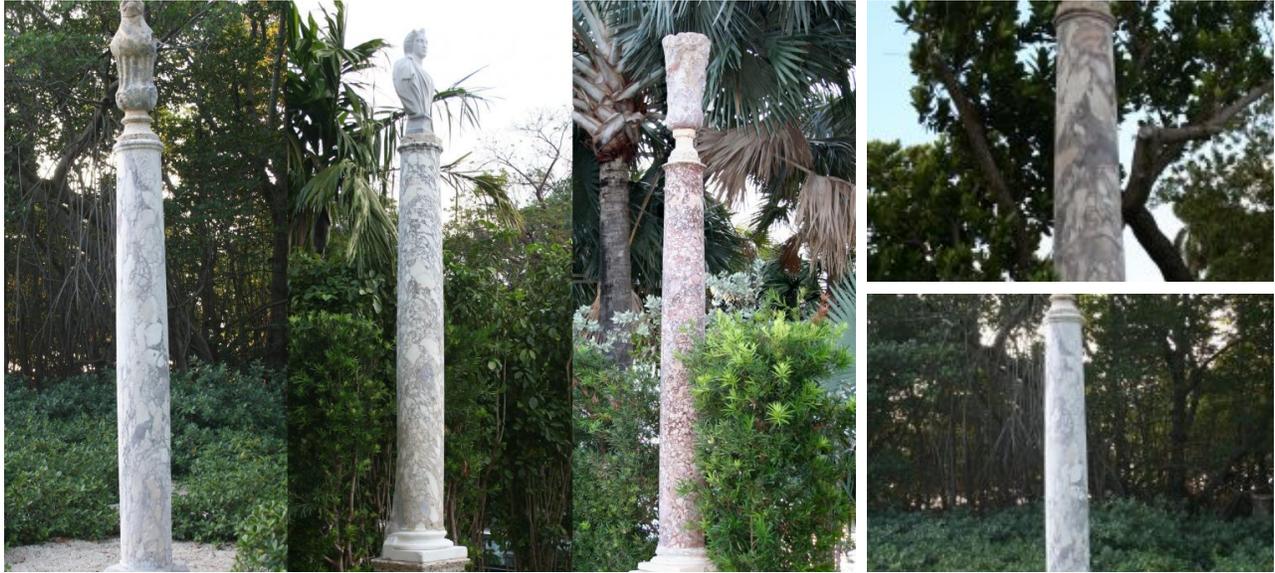
During a multi-year contract to treat all of the outdoor sculpture at Vizcaya Museum and Gardens, we conserved approximately forty monumental columns along the "statuary walks" of the estate. Some of these columns were imported from Europe, while others were custom-made pieces crafted locally from native coral stone. The columns are topped with Italian marble busts or urns. The columns comprise a large and significant portion of the outdoor sculpture collection, together with numerous architectural fragments, antique relics, and Baroque statuary.

A careful assessment was performed of each individual column and a comprehensive treatment program was developed for each with input and feedback from the curatorial staff. Issues of structural stability and life safety were considered to be of paramount importance. Many of the coral stone columns had been badly damaged by hurricanes; some had been fractured into three or four segments. The columns were typically stabilized with a grouted anchor that runs the full height of the column and ties it to the plinth; surface losses were rebuilt using patching mortar and textured to match the unique and porous stone surface. Several columns were found to be so deteriorated that they warranted replacement in kind. The associated bust or urn was also dismounted, iron pins removed, reassembled as needed, conserved and remounted.

A particularly challenging effort was the restoration of various brecciated and highly figured marble columns. Many of these exhibited significant dimensional losses, which developed as the unique stone matrix disaggregated and fractured. Previous repairs using colored mortars were not visually or materially satisfactory. After performing structural pinning of the columns as needed, the losses were cleaned of failed and inappropriate previous repairs and filled using a combination of marble mosaic and terrazzo techniques. A broad palette of marbles whose colors matched those of the original multi-colored stone was assembled for this purpose. Larger losses were filled with stone tesserae cut specifically to size and shape, while smaller losses could be filled with crushed stones laid into a colored mortar mix. Once set in place, the patches were honed with fine diamond abrasives to shape them to match the contours of the column.
