Canadian Parliament

PARLIAMENT HILL, OTTAWA, ON, CANADA

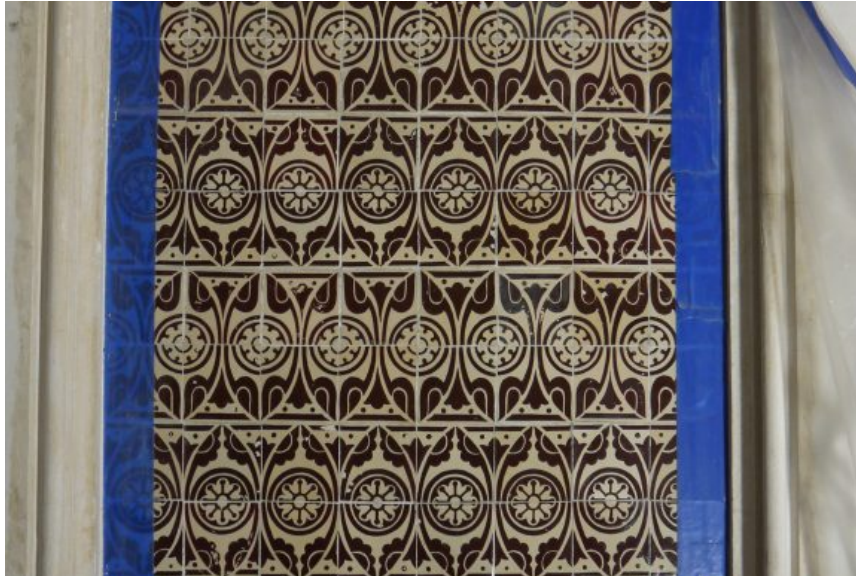
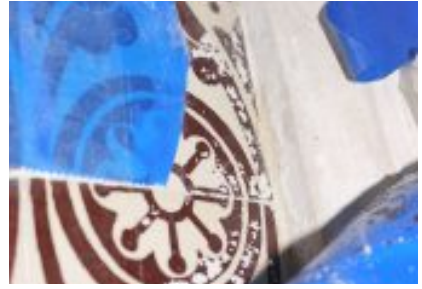
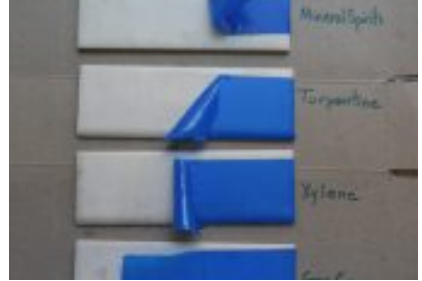
As part of the West Block Rehabilitation Project, the interior heritage spaces are also undergoing upgrades and renovations. At the request of the CM, we carried out an onsite assessment and treatment of the two heritage ceramic panels, dating to the construction of the Mackenzie Tower (1875-1878), located on the North and South Walls of the former Prime Minister of Canada's office and was transitioned for the current Prime Minister.

Mock-ups and testing of tape removal procedures and repairs were completed to identify the best methodology for the required work. Following mock-up approval, we treated each panel. Though initially identified as "painted" tiles, upon closer examination of the areas of loss, we noted the tiles consisted of two layers of coloured glaze. This is indicative of the crazing pattern noted on the base cream glaze and the overall surface finish typical of fired ceramics which provides a glossy appearance. This variation is common in fired ceramics and is caused by variations in the heat distribution and the type of environment used within the kiln. The manufacturer of the tiles is unknown.

Work was carried out sequentially to systematically treat all areas and to ensure that each procedure did not adversely affect the next. Areas of glaze loss and all repairs were in-painted and colour-matched acrylic paints were added layer by layer to provide the most accurate aesthetic finish.
