Painted Canvas Mural

DUKE ELLINGTON SCHOOL OF PERFORMING ARTS, WASHINGTON, DC

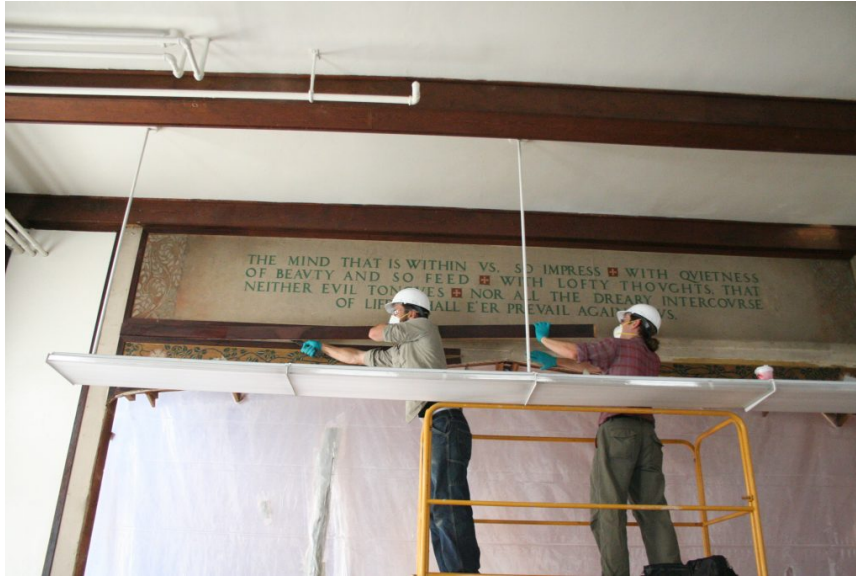
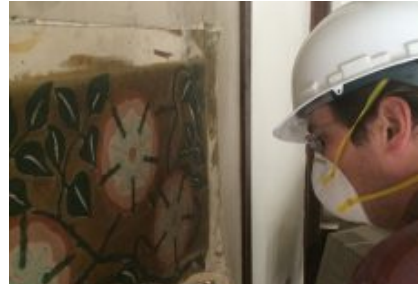
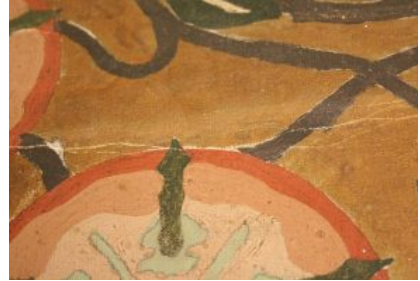
Our conservators removed the painted canvas from the site and transported them to us's conservation studio where they were photographed and assessed. Noted conditions included the deterioration of the painted surface, friable paint, surface cracks, material loss of the canvas, and overall soiling. These conditions commensurate with the age of the canvases and their continual exposure to UV light and dust.

We performed wet and dry cleaning tests. Dry cleaning was carried out with a HEPA vacuum and soft bristle brushes. Wet cleaning tests were then used to remove any soiling still remaining on the surface after the dry cleaning test (detergents and solvents: 3-5% Orvus WA Paste, swabs of distilled water, and 91% isopropyl alcohol). The results were documented and submitted in a condition assessment report with treatment recommendations.
