Carshalton Gates

PLANTING FIELDS ESTATE, OYSTER BAY, NY

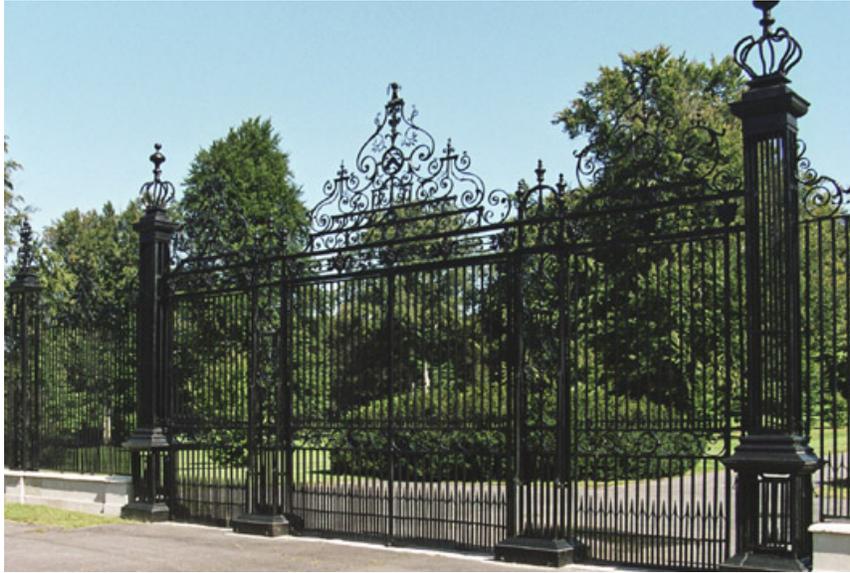
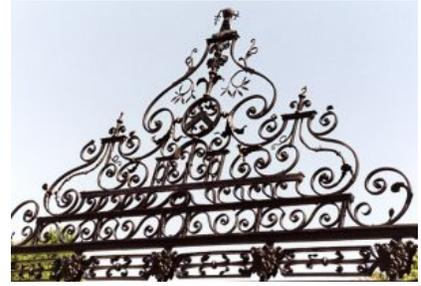
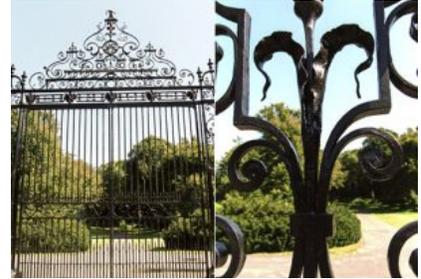
The Carshalton Gates are an extraordinary example of early 18th century English ironwork. Dating to 1711, these massive wrought iron gates exemplify the blacksmith's art as it existed prior to the invention of the Bessemer process and the inexpensive production of steel. Each element is hot forged into shape and held together with mortise and tenon joints, tightened with wedges and pins. The gates were removed from an English estate and installed in 1926 at The Planting Fields Estate, NY, one of the great houses on Long Island's Gold Coast.

Each element was stripped of existing coatings and assessed for damages and necessary repairs. Most losses were associated with entrapped water which led to rust formation. Work was divided into unit replacements, in-kind repairs and synthetic fills. Skilled craftsmen repaired losses in keeping with the original design and assembly details while removing water catch points.

Our conservators completed the restoration of the Carshalton Gates between 2003 and 2004. The gates were documented before removal from site. Careful measurements were taken to assure that the gates could be reinstalled after restoration. Paint analysis was completed prior to treatment to determine the original paint color and scheme by Tina Reichenbach, conservator of RichBrook Conservation. Seven locations were reviewed and selected together with Cameron Wilson of Wilson Conservation, the owner's metal conservation consultant, were found to have likely contained remnants of original paint. As the gates had been sand-blasted and substantially cleaned during the 1980s, few sites that held original paint layers could be found. Nevertheless, after being studied microscopically, six of the sites were found to retain fully or partially intact paint layers laying directly atop iron substrates.

Upon completion of the restoration, the gates were again cleaned and metallized before being coated with a high performance paint system. They were transported to the site and installed atop their restored stonework.
