Casino Parapet Figure

VIZCAYA MUSEUM AND GARDENS, MIAMI, FL

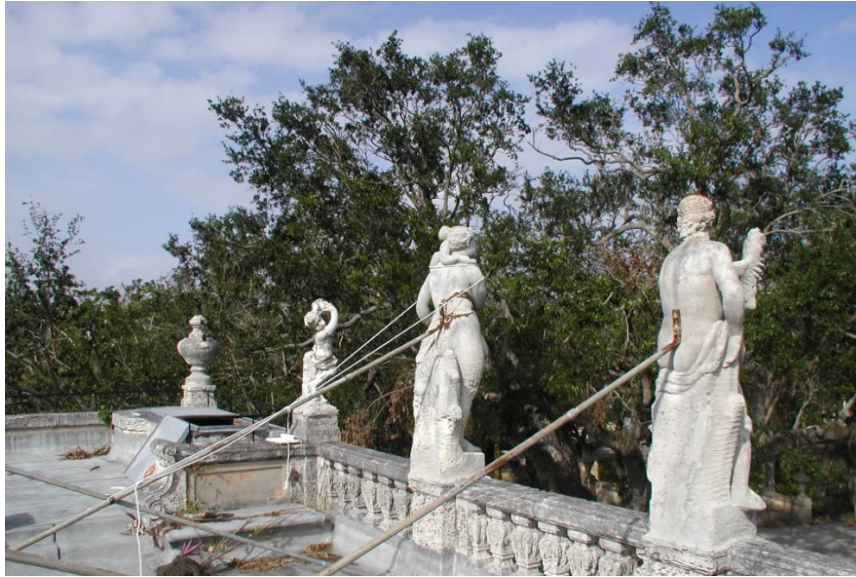
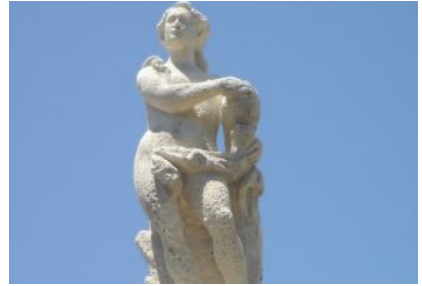
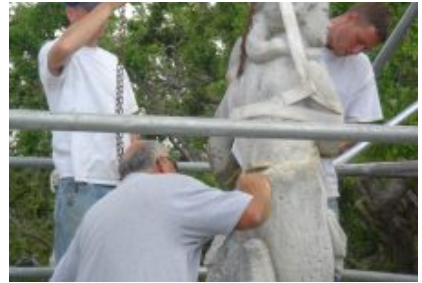
Sculptures atop the Vizcaya Casino were damaged during Hurricane Wilma. The original simple structural supports that had been installed were not effective at resisting this damage and, in fact, contributed themselves to the damage as fragile stone figures broke free from the supports at the mounting points and rocked against the now broken braces. Fortunately, no sculptural elements fell from the building but the damages confirmed that the mountings needed redesign as part of the sculpture restoration campaign.

A new free-standing stainless steel structure was engineered for four limestone figures on the building parapet. Each consisted of a tripod that was mounted to the building roof using a dismantlable method that allowed for future re-roofing of the building. The tripod supported a tubular "strongback" that ran vertically along the rear of each figure. The structure was designed to be as minimally visible from the ground as possible. All contact points between the support structure and the stone figures were padded with neoprene. Aircraft grade stainless steel cable, shielded in nylon sleeves, was wrapped around the figures at a minimum of three locations to provide support to the figures. The design intention was not to rigidly hold the figures, as previous damage had occurred at structural mounting points, but rather to provide support only to resist tilting should the stones move on their mounts. The stones would then pull against the cables, which only allow for a couple of degrees of movement. The mountings are nearly invisible from the ground.
