Cast Iron & Bronze Urns

COLORADO SPRINGS, CO

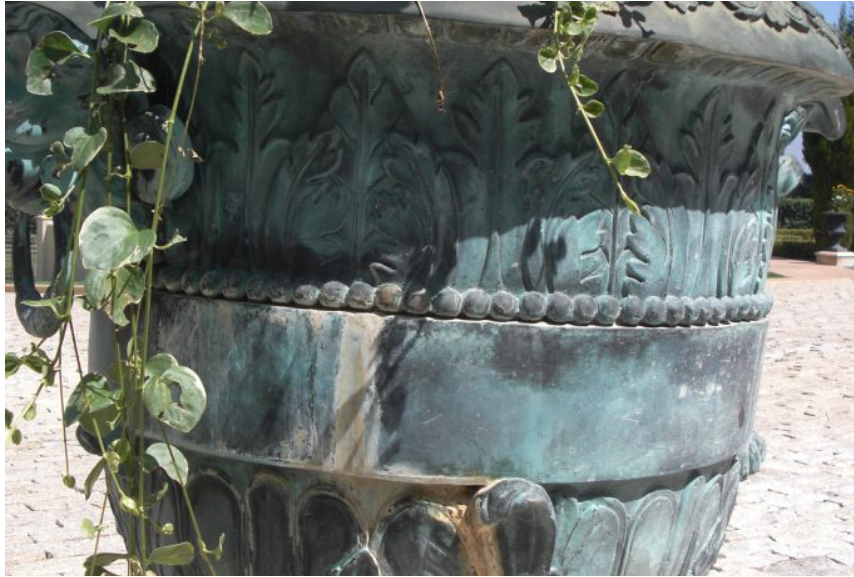
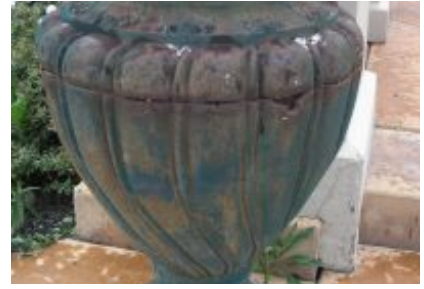
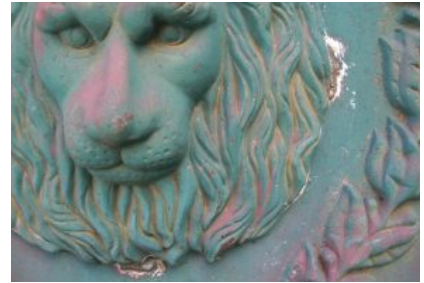
The urns had suffered from significant deterioration due to their outdoor exposure and failed coatings. Disfiguring corrosion covered all of the iron urns, and previous applications of paint had failed and were flaking. The two bronze urns had significant green, copper sulfate corrosion typical of an unmaintained copper alloy.

We assessed each urn individually and provided treatment recommendations for each. The proposed treatment for iron urns included removal and relocation to an off-site shop, cleaning, repairs, refinishing, and re-installation. The proposed treatment for the bronze urns included cleaning, re-patination, and re-coating. The recommended treatments will restore the appearance of the urns, and the protective finishes and coatings will protect them against future corrosion in their outdoor setting.
