Charlotte Miller Monument

UNIVERSITY OF VIRGINIA CEMETERY, CHARLOTTESVILLE, VA

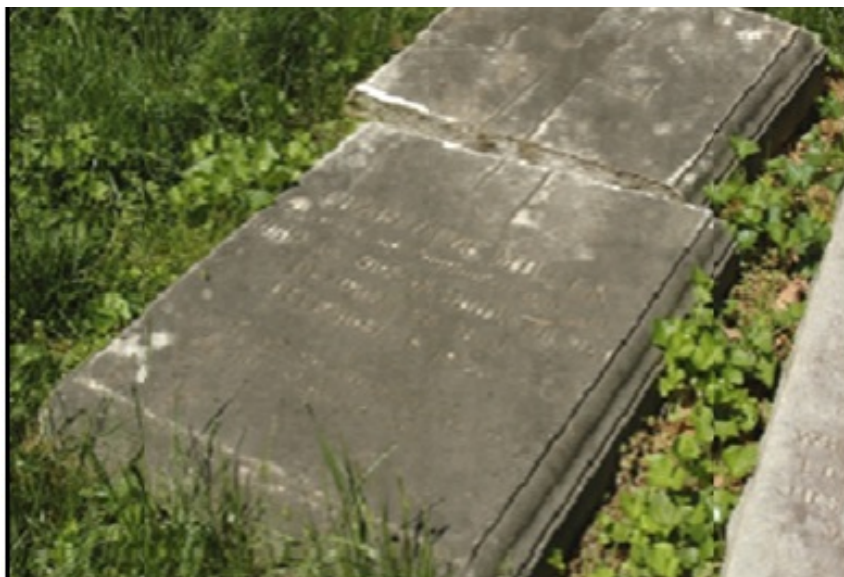
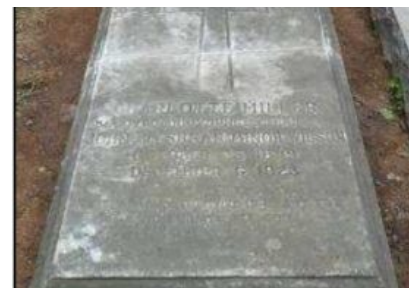
Founded in 1828, the Cemetery at the University of Virginia has served as the final resting place for many of the most prominent figures of the University. Burials of those who taught or were associated with the University have continued to this day. Moss covered headstones of marble and granite rest within mature stands of old growth trees inside the cemetery's stone wall enclosure. Long term erosion of the soil around headstones, markers and the old growth trees has put these monuments at risk. The fall of one of those trees in 2008 caused extensive damage to a number of the stones in the cemetery, including the white marble table stone of Charlotte Miller.

Working with staff from the University, the large table stone was carefully turned over onto its face onto a stable surface. The faces of the break were aligned, dowelled together with stainless steel pins set in epoxy and the fracture faces adhered with a lime-based adhesive. To provide additional support before righting the stone, two heavy gauge stainless steel angles were attached using a small quantity of stainless steel pins to the back face of the stone.

The table stone originally set on two footing blocks which were out of plumb. The bed was leveled in accordance to the existing pitch using gravel and soil. The stone was then righted and the angle irons were set level (side to side) with a slight pitch (top to bottom) to match the adjacent table stones. The face of the stone was only lightly cleaned with water to remove excessive soiling and the fractured edge was repaired with lime-based materials. Recommendations were provided for soil erosion control and monument maintenance.
