Charlotte Miller Monument

UNIVERSITY OF VIRGINIA CEMETERY, CHARLOTTESVILLE, VA

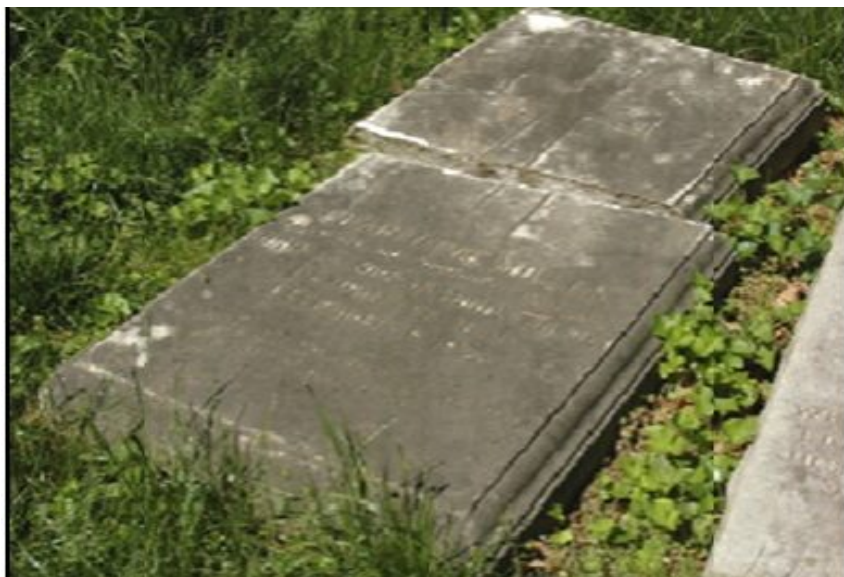
Founded in 1828, the Cemetery at the University of Virginia has served as the final resting place for many of the most prominent figures of the University. Burials of those who taught or were associated with the University have continued to this day. Moss covered headstones of marble and granite rest within mature stands of old growth trees inside the cemetery's stone wall enclosure. Long term erosion of the soil around headstones, markers and the old growth trees has put these monuments at risk. The fall of one of those trees in 2008 caused extensive damage to a number of the stones in the cemetery, including the white marble table stone of Charlotte Miller.

Working with staff from the University, the large table stone was carefully turned over onto its face onto a stable surface. The faces of the break were aligned, dowelled together with stainless steel pins set in epoxy and the fracture faces adhered with a lime-based adhesive. To provide additional support before righting the stone, two heavy gauge stainless steel angles were attached using a small quantity of stainless steel pins to the back face of the stone.

The table stone originally set on two footing blocks which were out of plumb. The bed was leveled in accordance to the existing pitch using gravel and soil. The stone was then righted and the angle irons were set level (side to side) with a slight pitch (top to bottom) to match the adjacent table stones. The face of the stone was only lightly cleaned with water to remove excessive soiling and the fractured edge was repaired with lime-based materials. Recommendations were provided for soil erosion control and monument maintenance.
