## Chrysler Building - Elevators

NEW YORK, NY

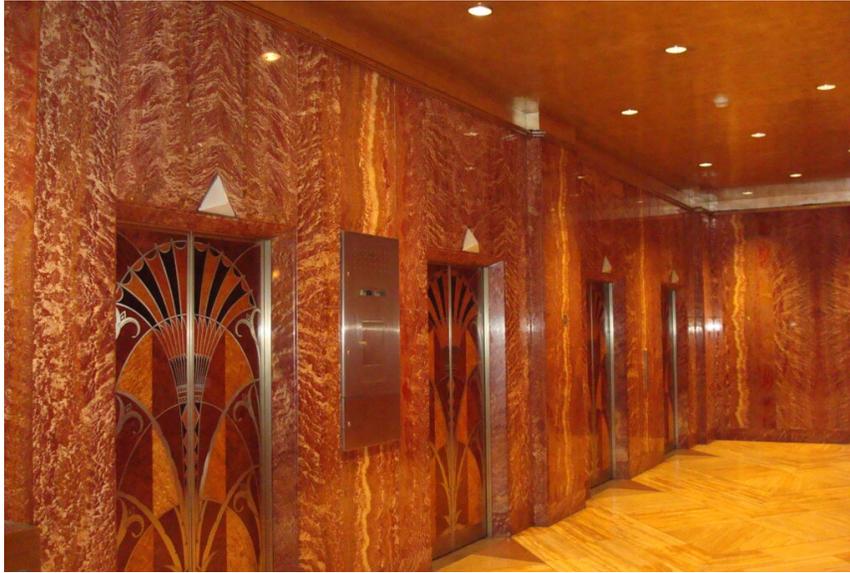
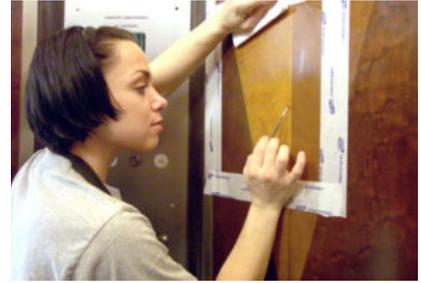
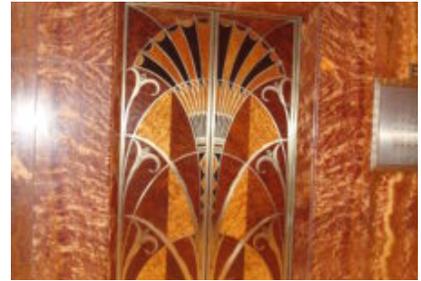
The elevator cabinets of the Chrysler Building were in poor condition. There were mild scratches, cracks, and dullness to the surface of the finishes as well as a debasement of color in the finish coats and of the color on the wood. Deep scratches and gouges were penetrating through the finish into the wood in places while there was cracking, buckling, or complete absence of veneer in others. Earlier areas of historical patching and sections of faux painting throughout the elevator cabinets also needed to be addressed.

EverGreene cleaned the cabinets and removed and repaired veneer by infilling and faux painting to match the surrounding wood graining, colors, and patterns. Our team filled and disguised gouges and deep scratches, and we made reparations to color damage in the wood and finished coats as well.

This process created a new, consistent surface and refreshed the depth, color, and richness of the original design...
