## Coral Limestone Herm

VIZCAYA MUSEUM AND GARDENS, MIAMI, FL

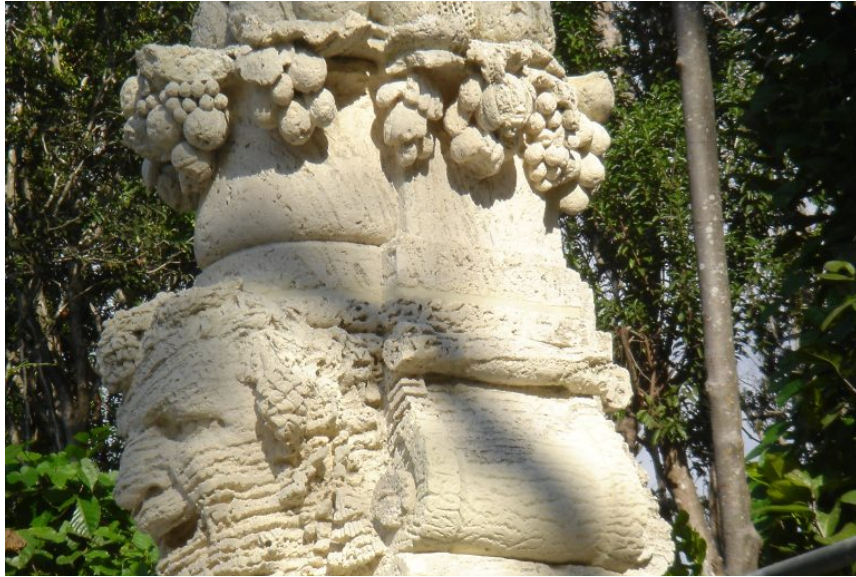
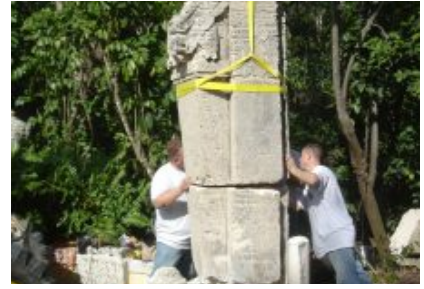
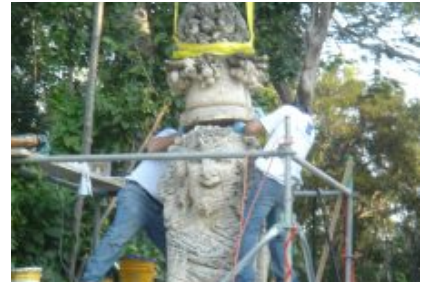
In 2006, one of the Herms was damaged when it was hit by a delivery truck. The fragile carved stone toppled into the adjacent plantings, breaking into three main pieces and numerous small fragments. Some of the smaller carvings on the headdress were broken beyond repair. The museum salvaged what could be saved and preserved the rest for restoration.

We were contracted to restore the damaged work. Rubber molds were made from matching elements on a similar Herm and replicas were created to replace irreparably damaged elements. Structural scaffolding was installed and the fragments were carefully hoisted, cleaned, and re-erected on their base. After reassembly was complete, the re-created elements were mounted and all losses were filled with a custom patching mortar. The highly figured graining of the weathered stone was carefully modeled into repair areas to build up areas of loss. Previous damages were undetectable upon completion of work.
