Saint Dominic Statue

DOMINICAN HOUSE OF STUDIES, WASHINGTON, DC

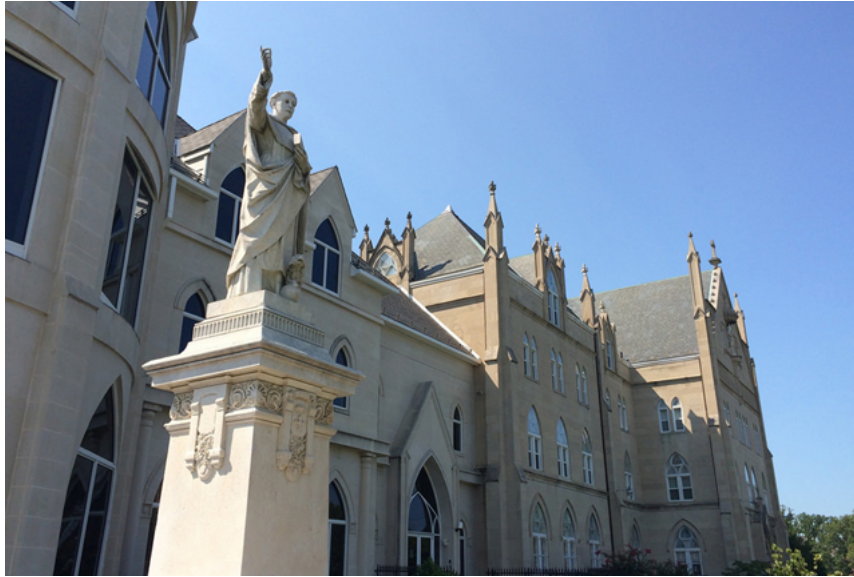
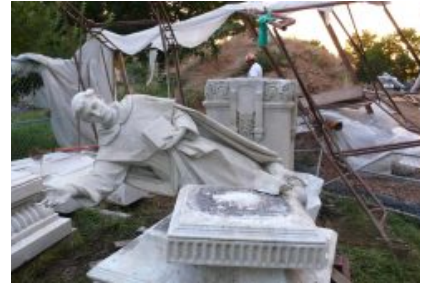
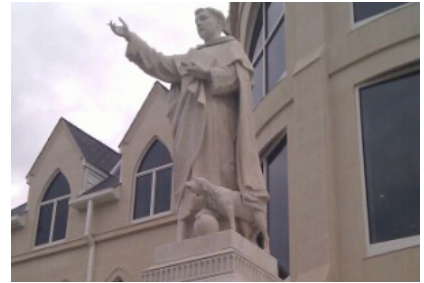
Carved of Italian Carrara marble in the mid-19th century, this statue represents the founder of the Dominican order preaching with his right hand raised. The over-life sized figure stands on a base with ornate carvings and detailed moldings. At his feet is the dog (the Saint's iconographic symbol), which appeared in his mother's dream foretelling his birth.

The marble had suffered from deterioration over the century and a half that it was exposed to the urban Washington, DC environment. Pollutants had slowly dissolved and eroded the pure calcareous marble and black gypsum crusts had formed in protected recesses. The sculpture was disassembled by the client and stored nearby during the construction of a new building at the site. An unfortunate windstorm caused additional damage from impact by flying debris as the statue was knocked from its base.

Our conservators were contracted to conserve the statue and restore the damage. The marble was carefully cleaned of soiling and gypsum crusts using filtered, intermittent water misting, detergent washing, gel poultices, and localized micro air abrasion. Pieces salvaged from the storm damage were remounted in original locations and losses were patched with custom formulated lime mortars. After curing, the entire marble was consolidated with a series of treatments.
