El Paso County Courthouse

EL PASO, TX

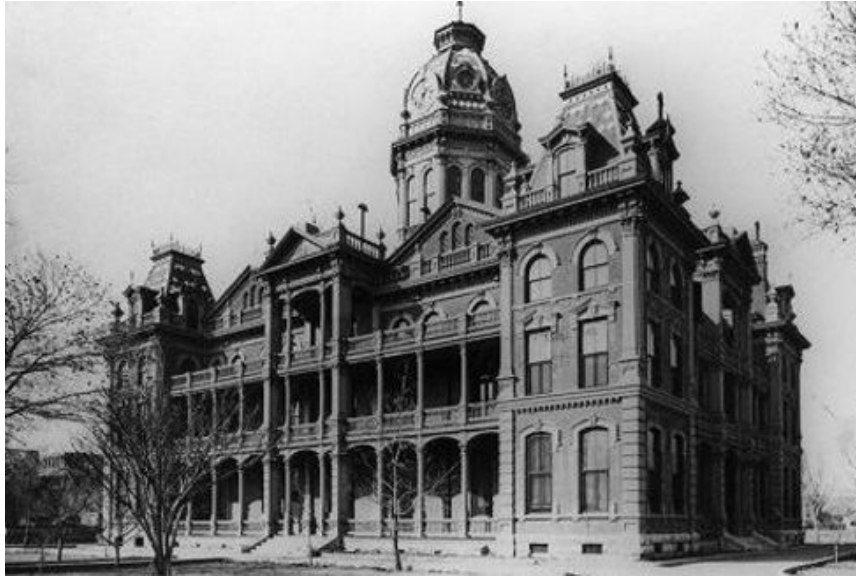
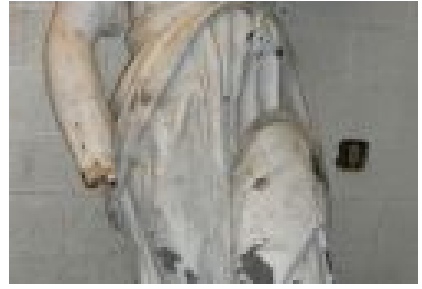
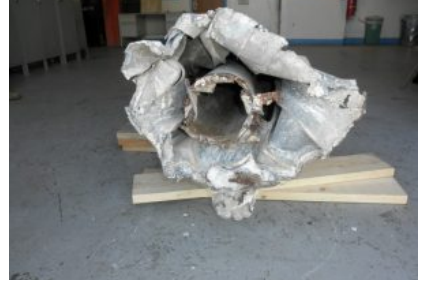
We were engaged in 2010 to perform a condition assessment to document the condition of the sculpture, make recommendations for its conservation, and provide a budgetary cost estimate for the recommended work. Major conditions and failures included wholly lost elements, minor voids and cracks, metal fatigue, corrosion, and a thick accumulation of failing coatings. Paint analysis documented over a dozen layers of white and off-white paint layers over a gray primer. Treatment recommendations included specific guidelines for coating removals, metal reforming and repair, fabrication of a new internal support system, surface preparation, and re-coating with a high performance paint system.
