El Dorado Building Art Deco Entrance

NEW YORK, NY

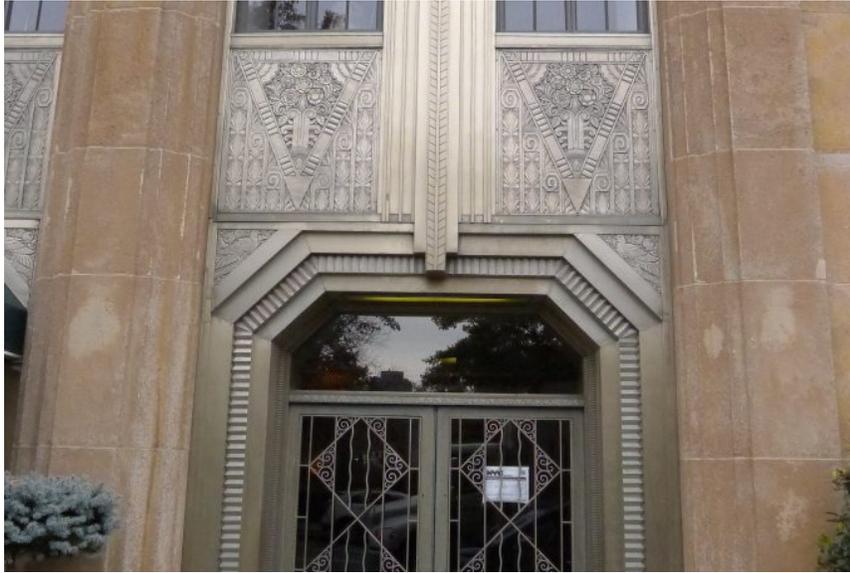
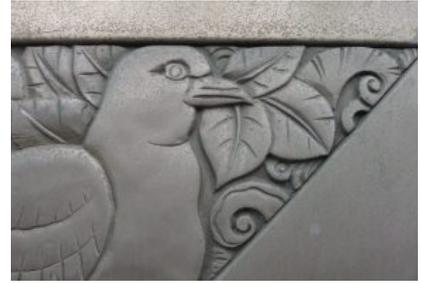
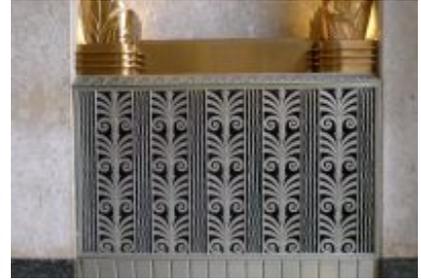
Although in remarkably good condition, the metalwork has taken on a dulled appearance and exhibits a greenish-brown patina and spots of green corrosion. We were contracted to identify the metals of the exterior entrances and interior lobby, determine the original appearance of the metalwork, identify the conditions affecting their appearance, and design a restoration treatment plan.

We identified the elemental composition of the metals through x-ray fluorescence analysis. The primary metal was found to be "nickel silver," a copper-nickel-zinc alloy popular in Art Deco architecture. Intentional variation of the ratio of elements in the alloy created a color scheme of contrasting white and yellow metals. We assessed the condition of the metalwork and provided specifications for the cleaning and repair of the metalwork to restore it to its original appearance.
