Entry Vestibule & Grand Waiting Room

UNION STATION, LOS ANGELES, CA

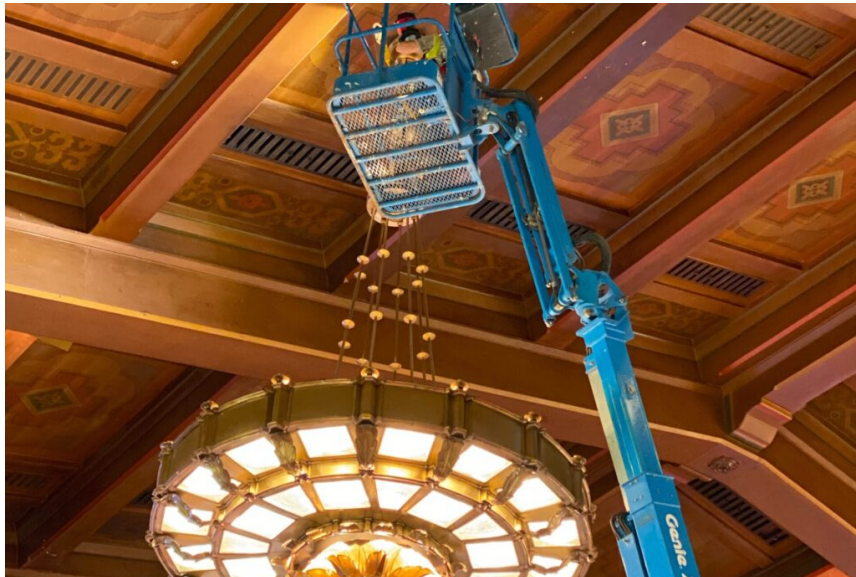
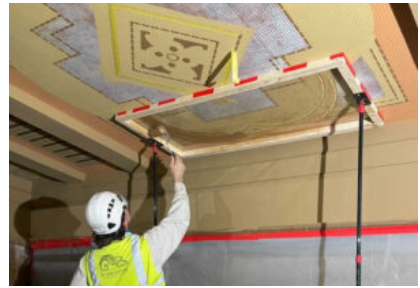
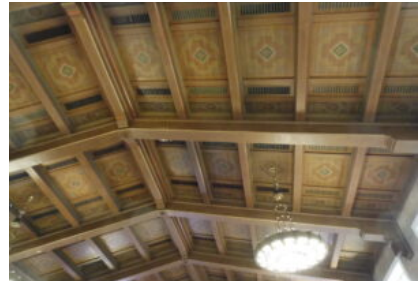
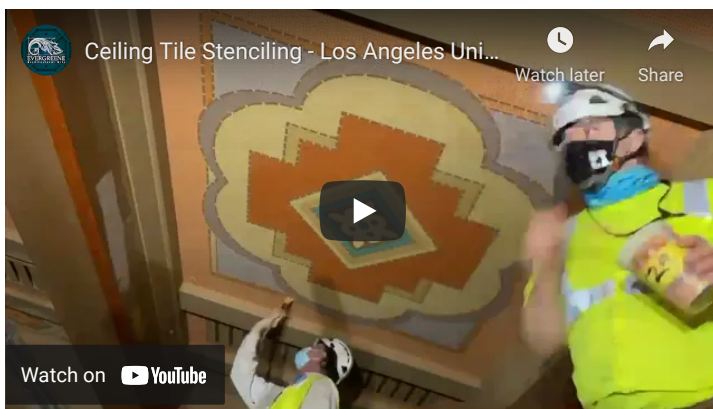
EverGreene was heavily involved in the rejuvenation of the Los Angeles Union Station; our work on the Entry Vestibule and Grand Waiting Room is the third phase of the larger project. Between 2017 and 2019, EverGreene restored [acoustic tile](#) throughout the Los Angeles Union Station as well as the ceiling tile of the [Ticketing Concourse](#). In 2020, we performed a visual survey of plaster beams and fiberboard acoustical tiles at the ceiling of the Grand Waiting Room in the Los Angeles Union Station Terminal. We found that the plaster beams exhibited heavy soiling and widespread instances of hairline cracking, with isolated areas of wider cracks, as well as localized paint failure. A total of 1,792 linear feet of cracks were observed during the survey. Decoratively painted acoustical tiles were well-adhered but also heavily soiled.

After creating mockups to devise the best approach, we cleaned, repaired/replaced, and repainted the plaster beams and fiberboard tiles following a restoration approach. Our craftspeople utilized the existing designs on the ceiling to guide the overpainting and replicated the color, pattern, sheen, and opacity of the original historic stencil and field decoration.
