## Flag House & Star-Spangled Banner Museum

BALTIMORE, MD

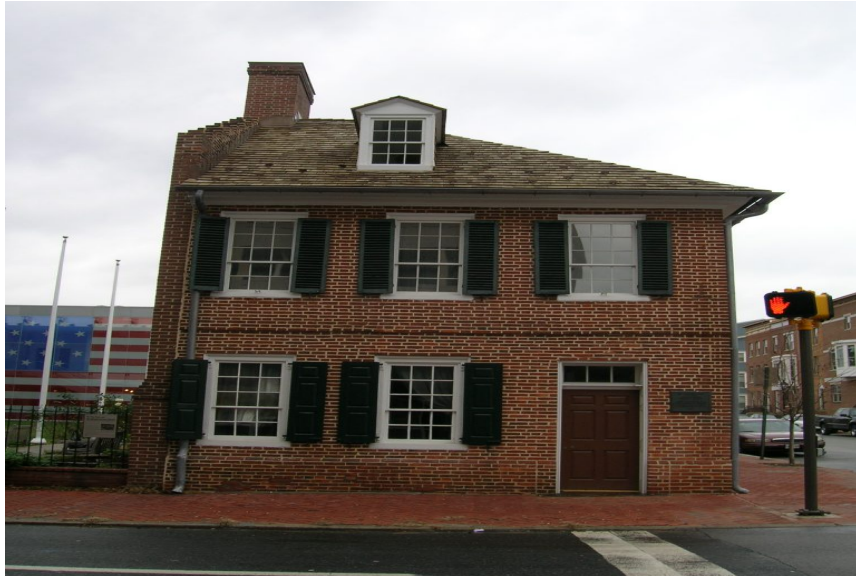
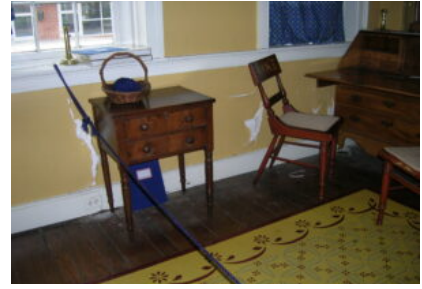
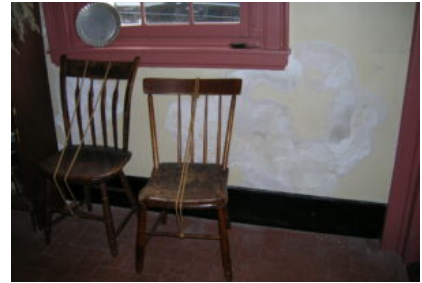
The building was exhibiting widespread failure of the interior paint and plaster finishes on the perimeter walls, up to a height of three feet above grade, suggesting significant rising damp. The paint was splitting and peeling, and the plaster beneath it was blooming with salt crystals (efflorescence). Wood baseboards in the hallway had rotted and already had been removed. Troubling piles of salt and disintegrated stone particles had accumulated along the rubble stone foundation.

We were contracted to assess the current conditions and determine the likely causes of the plaster failures and possible solutions. We performed a thorough survey of the building and site. Several openings were made to gain insight into hidden structural conditions. Brick porosity and moisture content were measured in-situ, and samples of mortar, salts, and paint were removed for off-site testing. We developed a comprehensive plaster conservation treatment plan with recommendations for correcting drainage, installing means of waterproofing, and for dehumidification and salt removal within the house...
