Stamp Mill

EMPIRE STATE HISTORIC PARK, GRASS VALLEY, CA

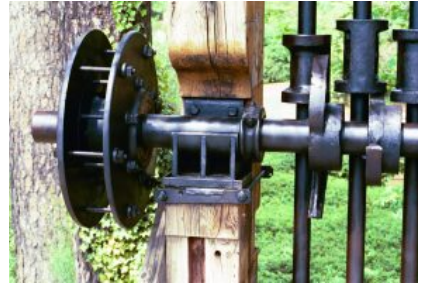
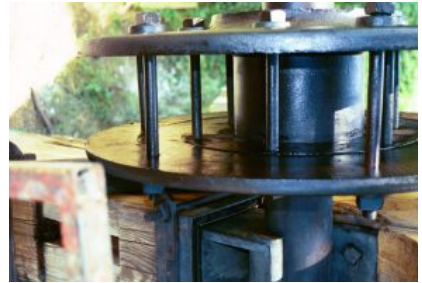
During the assessment of the artifact, it was found that the feed inlets on the mortar boxes were corroded through completely, one of the mortar boxes was cracked near the feed inlet, and there was a significant amount of unstable iron corrosion present on most of the metal surfaces. In addition, the wooden components suffered from significant dry rot and insect infestation.

Once the structure had been inspected and documented, all of the metal components were cleaned with soft natural bristle brushes and a 3% solution of non-ionic detergent and water. The surfaces were then cleaned using waterjets at approximately 2,000 to 3,000 psi to help remove loose corrosion products. The metal surfaces were then treated with a 3% to 5% solution of tannic acid. Once fully dry, all surfaces received two coats of a microcrystalline wax and were then buffed using cactus brushes and clean cotton rags. A conservation treatment report, which included photo documentation and a continuing maintenance plan for the stamp mill was compiled for the client.
