## Stamp Mill

EMPIRE STATE HISTORIC PARK, GRASS VALLEY, CA

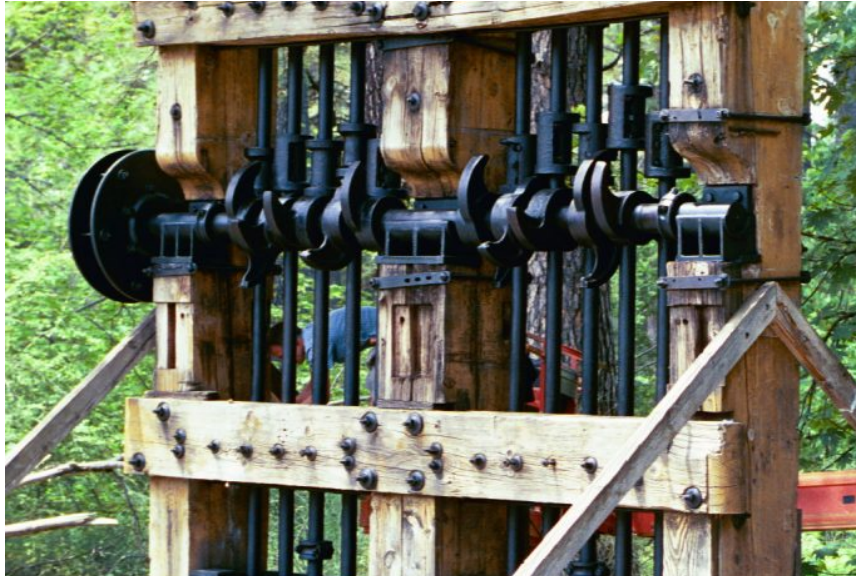
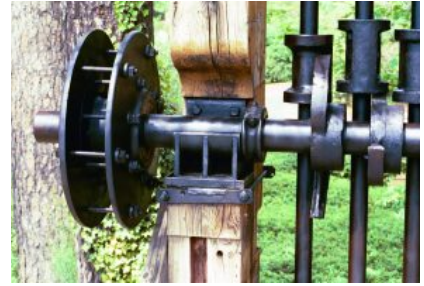
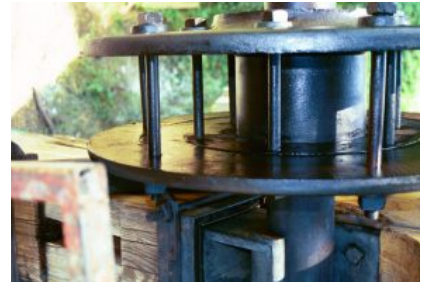
During the assessment of the artifact, it was found that the feed inlets on the mortar boxes were corroded through completely, one of the mortar boxes was cracked near the feed inlet, and there was a significant amount of unstable iron corrosion present on most of the metal surfaces. In addition, the wooden components suffered from significant dry rot and insect infestation.

Once the structure had been inspected and documented, all of the metal components were cleaned with soft natural bristle brushes and a 3% solution of non-ionic detergent and water. The surfaces were then cleaned using waterjets at approximately 2,000 to 3,000 psi to help remove loose corrosion products. The metal surfaces were then treated with a 3% to 5% solution of tannic acid. Once fully dry, all surfaces received two coats of a microcrystalline wax and were then buffed using cactus brushes and clean cotton rags. A conservation treatment report, which included photo documentation and a continuing maintenance plan for the stamp mill was compiled for the client.
