## Holy Redeemer College

WASHINGTON, DC

Investigation, Testing & Analysis  
Surveys & Condition Assessments

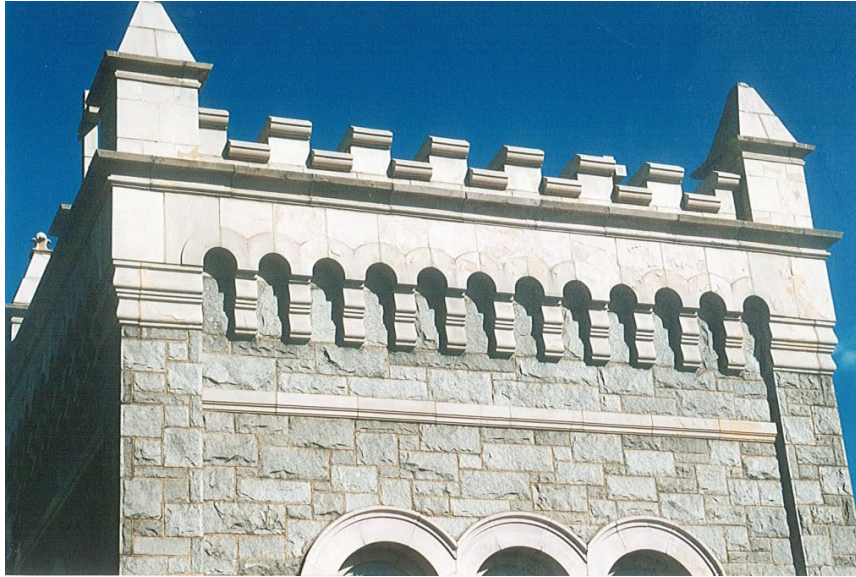
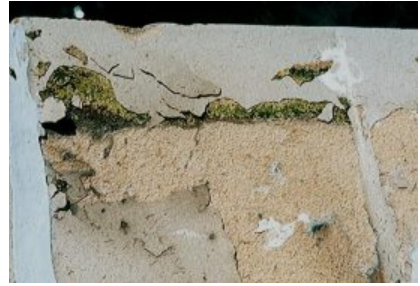
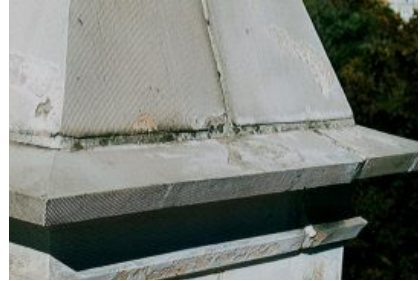
Although the dense granite was generally stable, the terra cotta was failing widely. Moisture infiltration had caused pervasive cracking and crazing of the glaze. Internal ferrous pins had begun to corrode and expand. The resulting forces led to spalling, and bursting of the units. Conditions were exacerbated by the poor quality of the terra cotta to begin with. Failed mortar and caulk joints, coupled with leaky roofs, were allowing additional water to enter the building. The moist climate encouraged significant biological growth and soiling.

We were contracted in 2002 to perform an investigative study, analysis and testing of this building. The goals were to determine the nature of the materials and associated failures. We documented existing conditions and identified specific problem areas. Testing was performed to determine the most efficient means of removing the salts from the terra cotta substrate. The results of the investigation were synthesized to develop treatment recommendations for each material type. Recommendations were presented by priority to the client, and stressed the need to make the building water-tight to prevent recurring damage.
