Hotel Washington Wall Ornament

WASHINGTON, DC

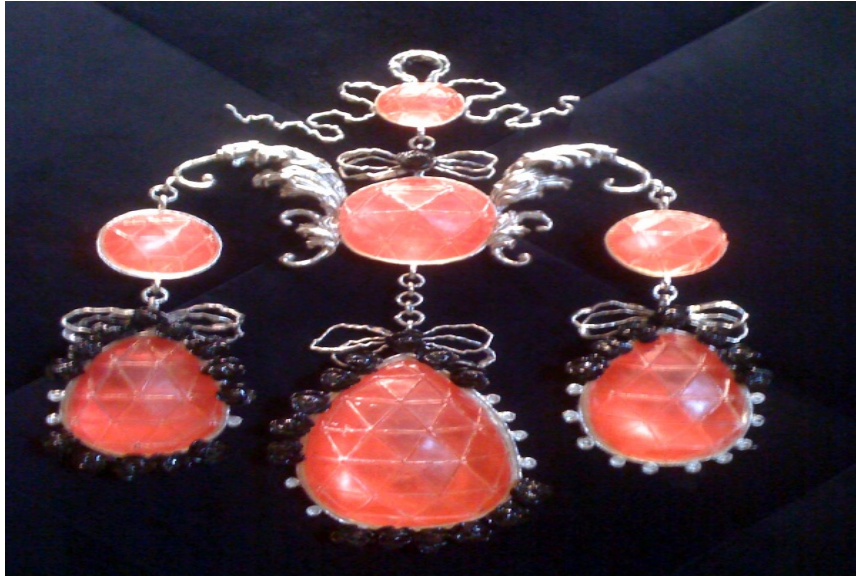
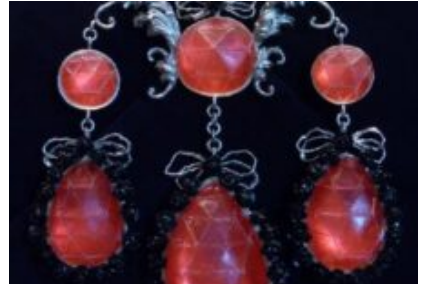
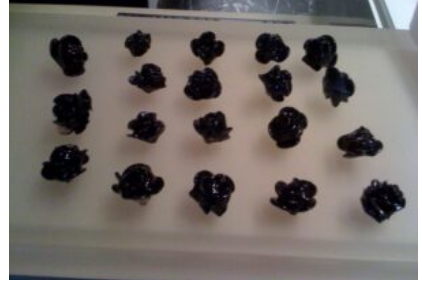
We were contracted to perform conservation services on a decorative object which had been acquired to adorn the wall behind the reception desk. The piece is a large jeweled fixture, with faceted glass cabochons set into a metal frame, encircled by small glass rosettes. Although new, the ornament had been damaged during transportation to the site, causing nearly half the rosettes to become dislodged. Because the hotel was scheduled to reopen in less than one week, art handlers hung the ornament in its final location despite its condition.

Working under extreme scheduling and site limitations, conservators carefully cleaned the loose glass ornaments and the settings using fine dental tools, scalpels and wire brushes. The elements were wiped cleaned with solvents to eliminate adhesive residue. Conservators took the ornament's high-traffic location into consideration and identified a successful combination of two adhesives that would impart both tenacity and some flexibility to the rosettes, to prevent them being easily dislodged by accidental contact in the future. Minor losses to selected rosettes were rebuilt using an epoxy putty and carefully in-painted.
