## High Bridge

NEW YORK, NY

The High Bridge, connecting Manhattan and the Bronx over the Harlem River, was part of a gravity-fed aqueduct which supplied New York City with water from the Croton River. In the early 1860s, the original cast iron pipes were augmented by the "Great Croton Pipe", a huge vessel made of Baltimore charcoal pig iron which was estimated to triple the volume of water handled. Although it no longer carries water, the structure remains the oldest surviving bridge in the city.

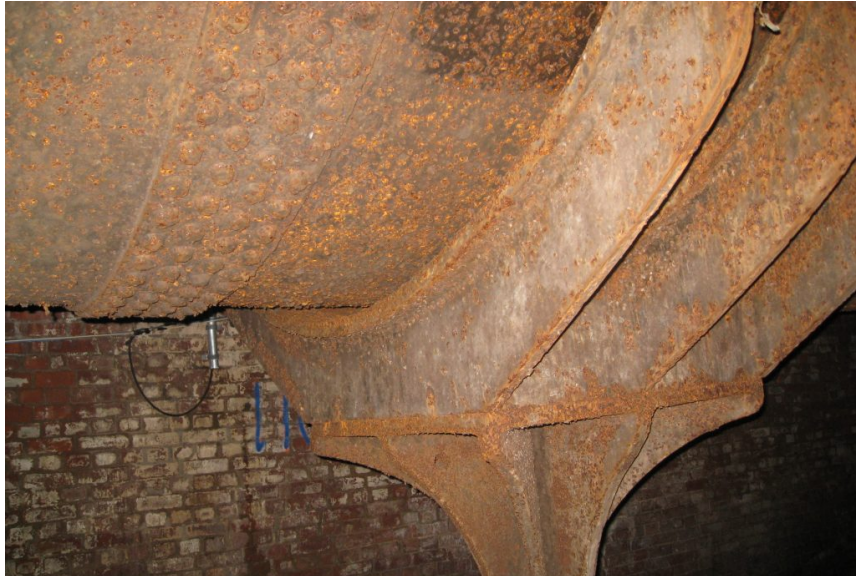
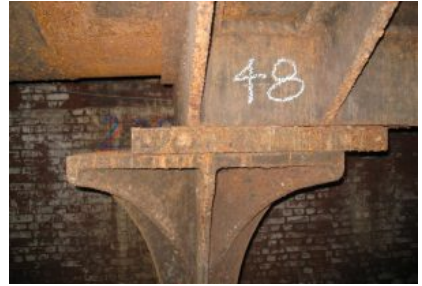
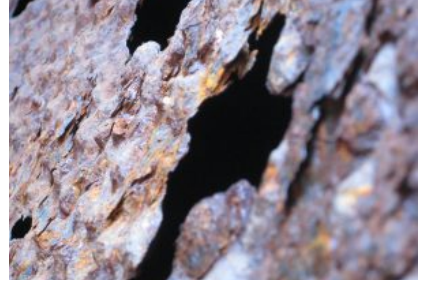
The pipe has been severely compromised by moisture; humidity, leaks and directed condensation have caused blistering, flaking, and even localized complete losses of the major pipe. Additionally, where a single steel span replaced five deteriorated arches in the 1920s, the exposure has led to pitting, calcite runs from overhead masonry, and the accumulation of bird guano.

We were contracted in 2010 to perform a preliminary condition assessment, as part of an effort to restore and reopen the bridge to pedestrian access. The various iron elements and environment were surveyed, conditions noted and measurements systematically taken, including relative humidity and surface temperature. Samples were collected for laboratory salt identification and additional microscopic characterization. Observations regarding conditions, likely causes, and practical recommendation of treatment were synthesized into an assessment report.
