Venus Statue

WASHINGTON, DC

We performed conservation treatment on the Venus stature, a cast lead figure upon a cast stone base. The figure, cast in Italy, is located in the landscaped estate of a private residence in Washington, DC.

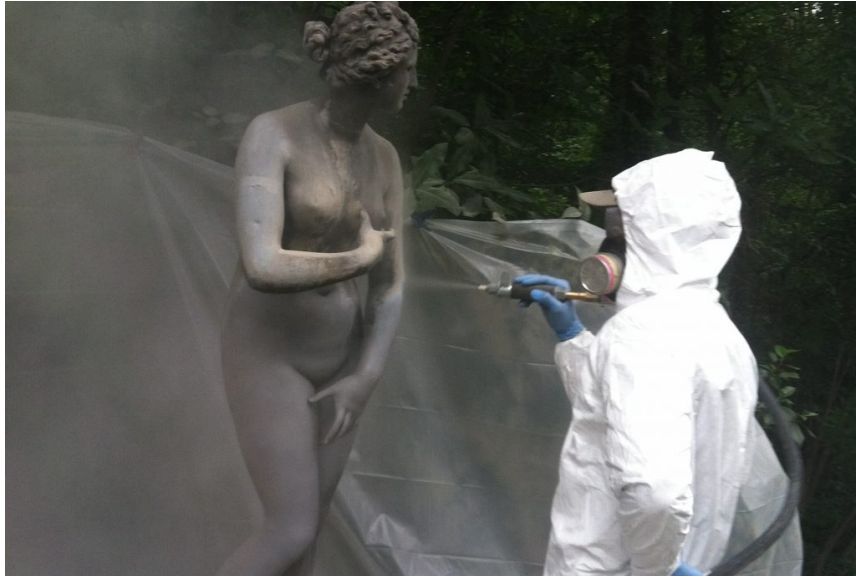
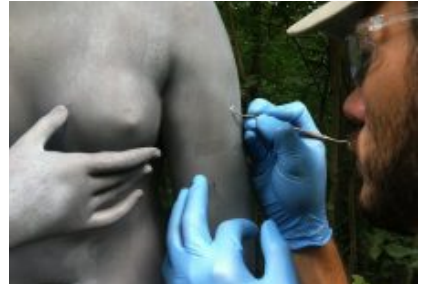
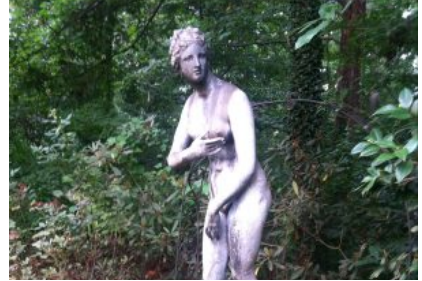
The lead statue had experienced weathering resulting in protective wax failure and lead oxide. The figure exhibited dents, stress fractures and areas of material loss, problems characteristic of the relatively soft metal. Dents and areas of loss had been filled with an inappropriate material and required removal. Corrosion was removed using a low-pressure micro-abrasion system. Given lead's toxicity extensive site-protection was erected to contain contaminated blasting media.

The cast stone base exhibited extensive biological growth and paint loss. Non-ionic detergent, and D2 biological solution removed soiling and biological growth from the base.

Once the corrosion was removed, the inappropriate fills were removed with dental picks. Fractures, voids, and dents were filled with a titanium metal-bulked epoxy. These fills were tooled and textured to mimic the surrounding original material. The figure was then patinated with several applications of an oxalic acid solution and coated with a paste wax.
