M & T Bank

WILMINGTON, DE

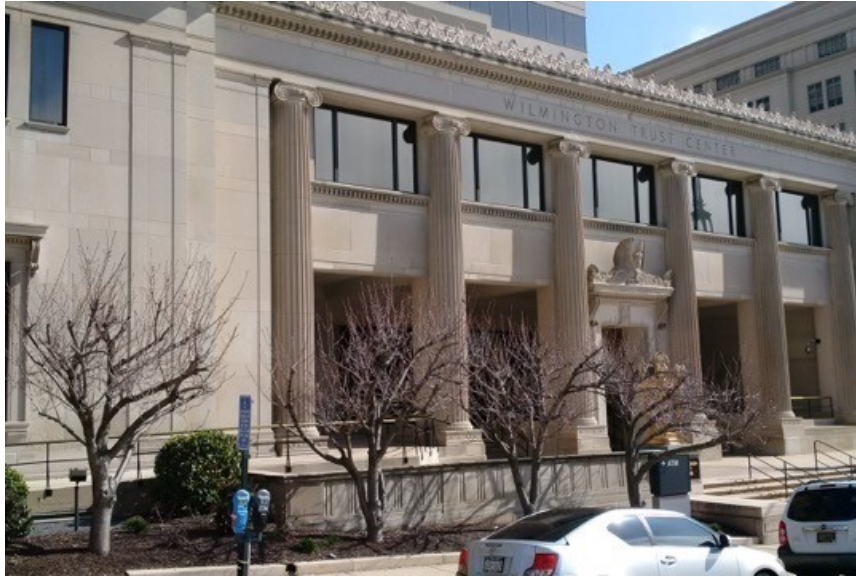
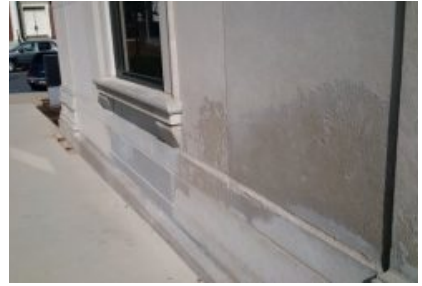
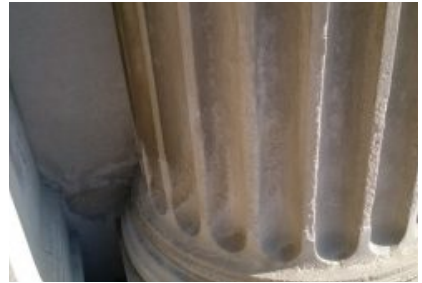
The M&T Bank Building fronts the north side of the Rodney Square in downtown Wilmington, Delaware. The original 3-story Indiana limestone building was designed between 1933 and 1935. The building was listed on the National Register for Historic Places in 1979. The condition of the limestone was found to be in varying degrees of deterioration including discoloration, efflorescence, cracking, granular disintegration, blistering, flaking, and peeling.

We were contracted to perform material testing, which focused on the deteriorating columns flanking the entrance and on blocks abutting the handicap access ramp. Areas without deterioration were used for comparison. Several test-methods were used including infrared thermography, water absorption, and salt characterization. Additionally, original architectural drawings were studied to consider engineering and drainage factors. The findings were detailed and provided to the client, including recommendations for treatment and photographic documentation.
