Limestone Sphinxes

BILTMORE ESTATE, ASHEVILLE, NC

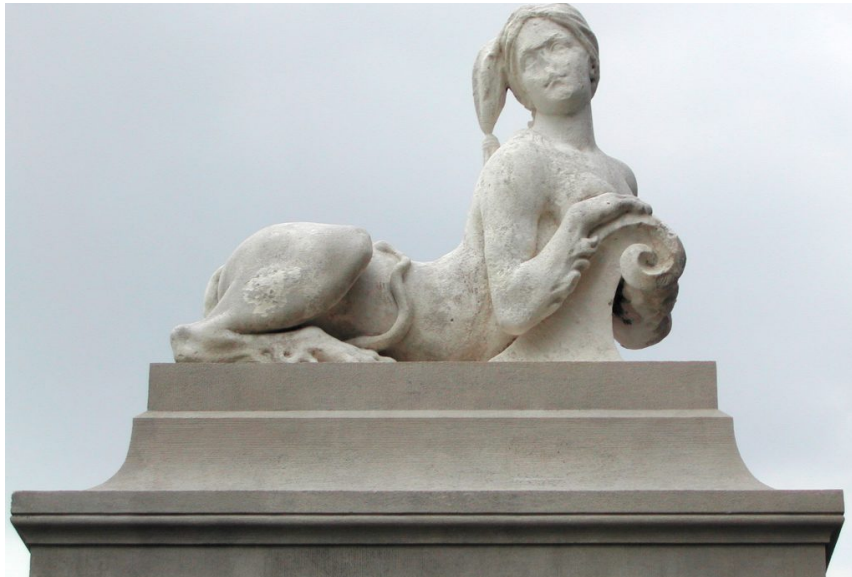
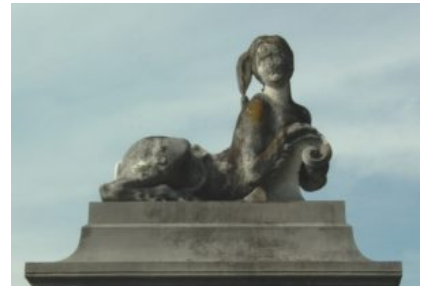
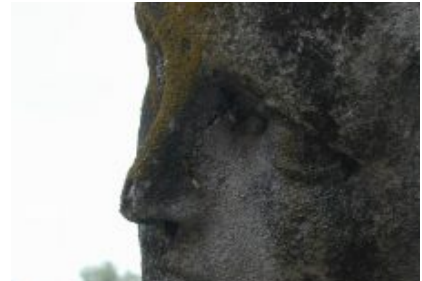
Even the mild North Carolina mountain climate caused deterioration of these fragile stone sculptures. Previous repairs using iron pins and inset dutchman repairs caused substantial deterioration and increased losses on the four sphinxes, which were literally fragmenting when inspected. Limbs and tails were missing and other elements had been lost from these fragile carvings. Substantial biological growth, including moss and lichen colonies, as well as typical green and black biota, masked all of the sculptural features.

Our conservators worked with Biltmore Estate's conservation staff to clean and restore the sculptures. Failed mortar and fills were removed. All surfaces were cleaned using appropriate detergents and biocides. Biological growth was also removed by careful picking with wood skewers. Failed fills were repaired or recreated with custom color-matched mortar. Cracks were filled with lime injection grouts. A treatment report with recommendations for follow up treatment was submitted upon completion of the work.
