Marble Balustrade

VIZCAYA MUSEUM AND GARDENS, MIAMI, FL

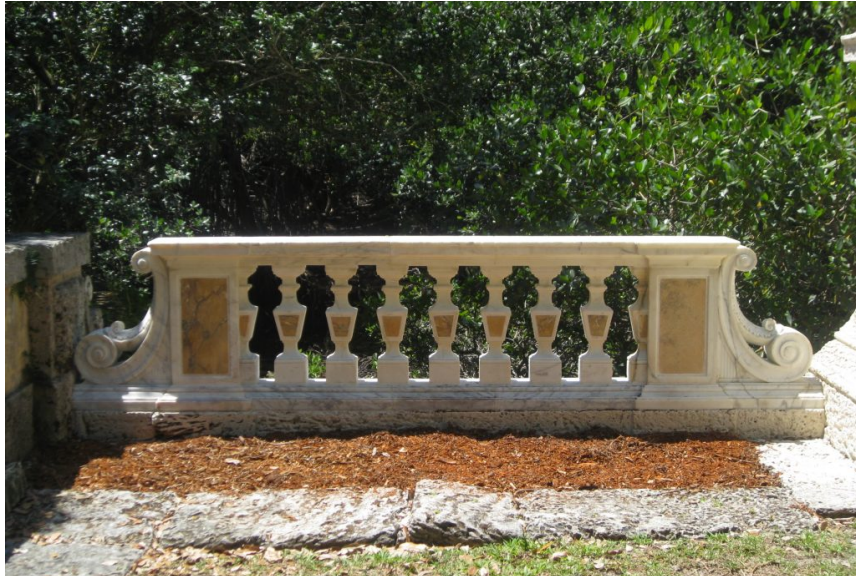
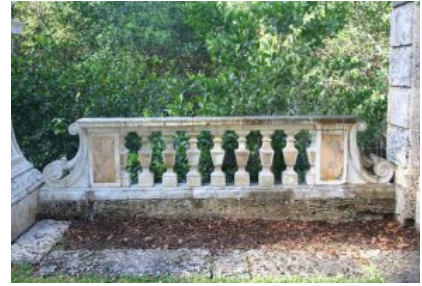
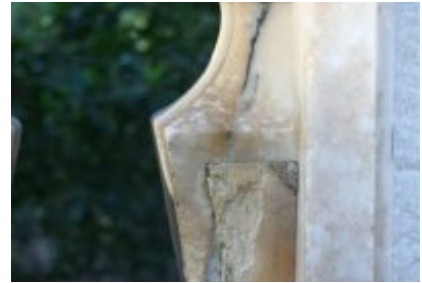
These balustrades were exhibiting heavy atmospheric and biological soiling. Mortar joints were open and failing and there were several open skyward-facing cracks. There were multiple balusters from which the orange/white marble inlays were missing. Balustrade rails were displaced and several balusters had become completely detached.

We were engaged by Vizcaya Museum and Gardens to perform surveys and condition assessments, in addition to implementing conservation treatment. We assessed each balustrade individually from which conservators developed CAD plans detailing the conditions and treatment recommendations. We implemented the prescribed treatments which consisted of deconstruction, cleaning, and removing failed previous repairs. Poor-quality cast stone units were replaced with Dutchman repairs from salvaged stones. Missing stones were then replaced with stones that were in-kind. Lastly, the balustrades were reconstructed to be level and true.
