Urn Fountain

KYKUIT, ROCKEFELLER ESTATE, TARRYTOWN, NY

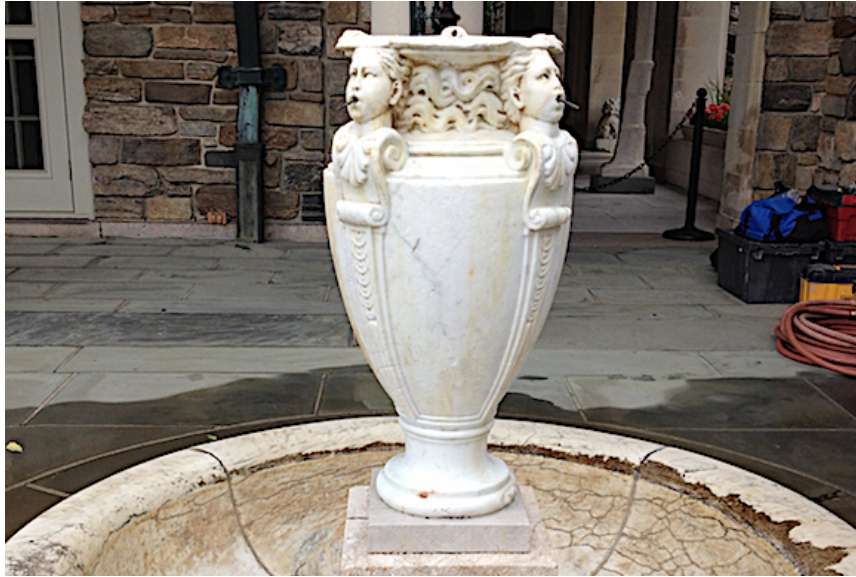
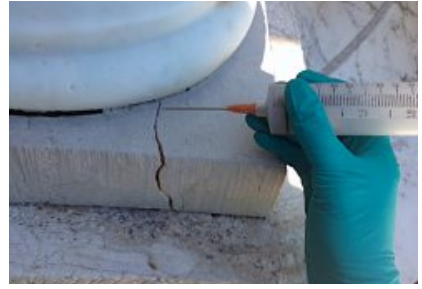
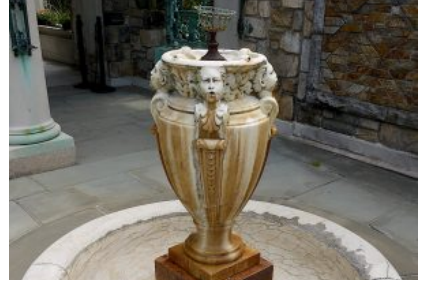
The Marble Urn Fountain is located at Kykuit, the John D. Rockefeller Estate in New York. The fountain consists of a marble vase; four heads decorate the neck of the urn. The urn rests on a square plinth and pedestal, both of cast stone. Water emerges from copper spouts in the mouths of the marble heads, as well as from the mouths of four fish-like creatures. The surface of the marble had become eroded and several breaks with failing repairs were noted. Heavy iron stains and dark biological staining marked the surface.

The fountain was cleaned with a solution of hot water and detergent. Iron stains were reduced using a paste in water and gently scrubbed with nylon bristle brushes. Dark stains in crevices were reduced using a marble and limestone cleaner. Dental tools were used to remove debris from fissures and hairline cracks, which were then filled with a lime-based injection grout. A detached fragment of the basin lip was readhered using a marble adhesive. One copper waterspout was replaced. To slow deposits of iron staining, the marble was waxed using a soft cloth and then buffed. We provided recommendations for maintenance, including water treatment and yearly waxing.
