The Old Post Office Historic Vault

WASHINGTON, DC

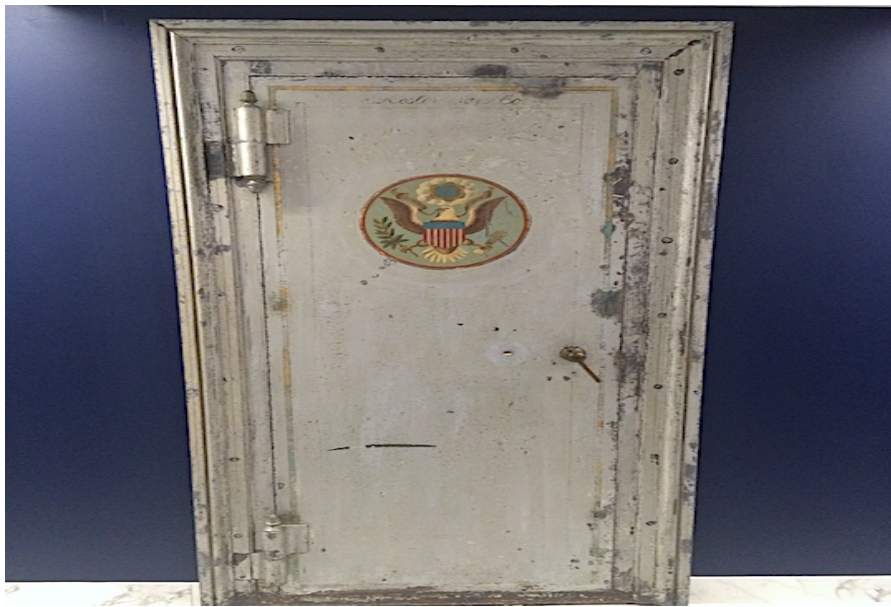
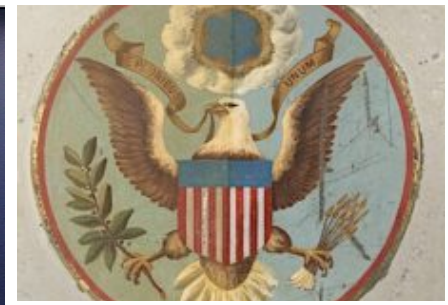
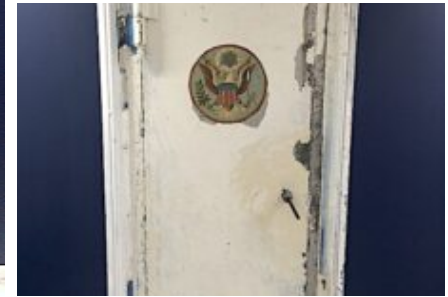
During the complete renovation of the Old Post Office Building at 1100 Pennsylvania Avenue, NW, a remarkable historic artifact was rediscovered: a long-forgotten steel vault door concealed beneath decades of over-painting in the building's basement. Investigations revealed that beneath more than a century of accumulated paint lay an exquisitely decorated surface, complete with gilded moldings and a richly colored Great Seal of the United States—still intact.

Our conservation team undertook a meticulous, multi-stage treatment to preserve and reveal this extraordinary find. More than 100 years of non-original overpaint were carefully removed using controlled methods to avoid disturbing the original decorative finish. A discolored varnish layer, which had significantly altered the appearance of the surface, was then reduced to recover the original color balance and clarity of the design. Areas of paint loss on the Seal and exposed metal were sensitively in-painted to restore visual continuity, while ensuring all interventions remained reversible and historically appropriate. Finally, the original paint—now stable and fully visible—was sealed beneath a conservation-grade lacquer to protect it for future generations.
