Renaissance Wellhead

ASHEVILLE, NC

As part of our on-going work with the Biltmore Estate, we were contracted to conserve the Rosso di Verona marble wellhead located at the entrance to the mansion. The Venetian Renaissance work incorporates a lead liner within the carved stone structure. It is typical of the elegant decorative structures that once enclosed fountains in town centers and villas throughout the Veneto. This example is enlivened with lions heads and floral bas-relief carvings on the faces and bracketed herms at the eight corners.

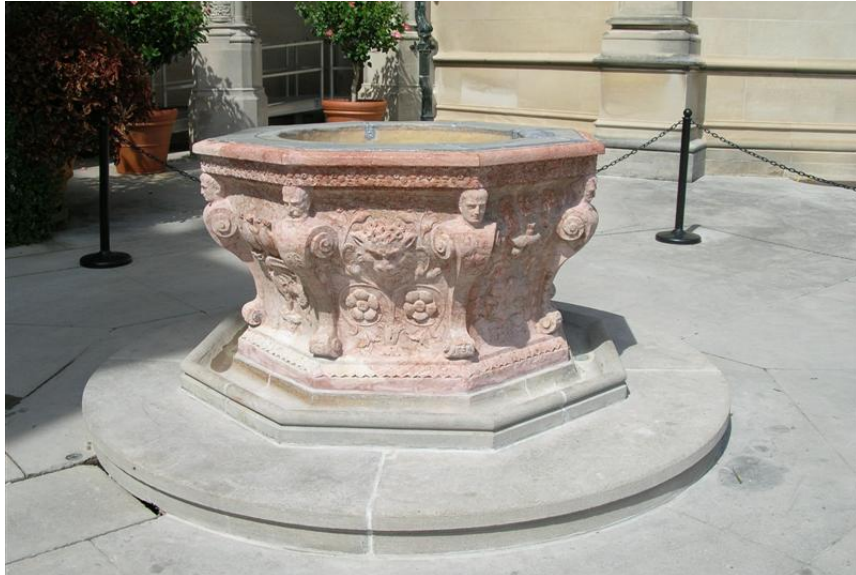
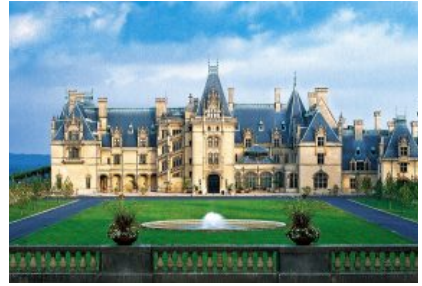
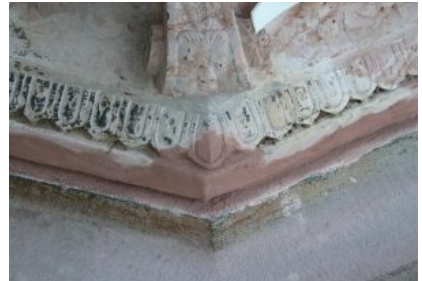
The wellhead exhibited typical deterioration associated with outdoor masonry artifacts. Failed mortar joints allowed water to enter the sculpture causing damage from freeze/thaw cycling. Early repairs had failed leaving losses and additional locations where water could enter the sculpture. The solder joints had also failed inside the basin. Biological growth, lime scaling, and general soiling hid the beautiful carvings on the faces.

Our conservators worked with the Biltmore Estate's conservation staff and specialty sub-contractors to clean and restore the wellhead. Failed mortar and fills were removed. All surfaces were cleaned using appropriate detergents and biocides. Biological growths were also removed by careful picking with wooden skewers. The lead liner was cleaned and re-soldered. Failed fills were repaired with custom color-matched mortar and all joints were repointed. A follow up conservation treatment plan was developed for implementation by the Estate's staff.
