## Biltmore Estate Romanesque Fountain

ASHEVILLE, NC

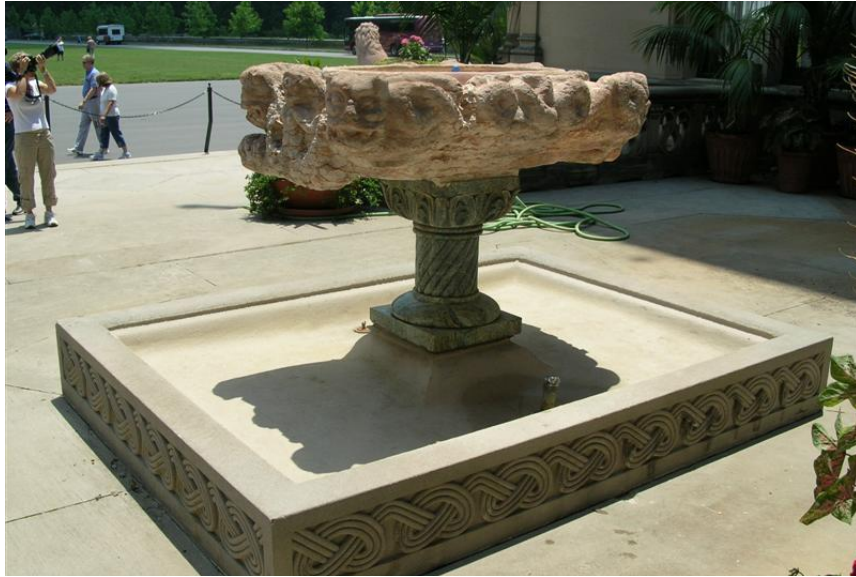
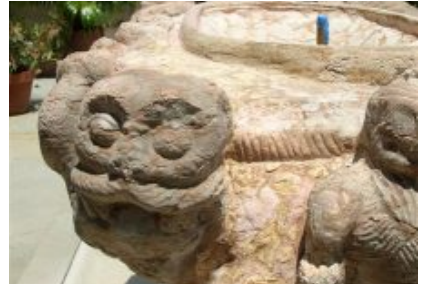
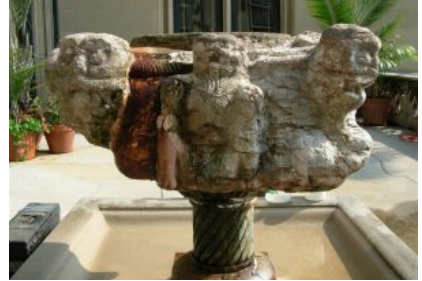
As part of our on-going work with Biltmore Estate, we were contracted to conserve the marble Romanesque fountain located at the entrance to the mansion. The marble fountain is constructed of a carved basin of Rosso di Verona marble, a variegated pink marble, a pedestal base of green marble, and a limestone splash basin. The carvings depict the likenesses of lions and serpents. Water flows over the lip of the basin and runs through the time-worn surfaces between the animals and into the limestone splash basin.

Our conservators worked with the Biltmore Estate's conservation staff to clean and restore the fountain. The focus of the treatment was to remove surface soiling, biological growths and staining, reverse and remove failed previous fills, and repair a large loss to the lip of the pink marble basin which caused the water to flow preferentially over the back side of the basin.

All surfaces were cleaned using appropriate detergents and biocides. Biological growths were further removed by careful picking with wooden skewers. The lip was repaired using a custom colored mortar. The extensive iron staining on the green marble pedestal was removed with multiple applications of poultice. Maintenance recommendations were provided along with training for Biltmore staff in the procedure to regularly treat the basin with a biocide to reduce the recurrence of biological growth.
