Saturn V Display Conservation

KENNEDY SPACE CENTER, TITUSVILLE, FL

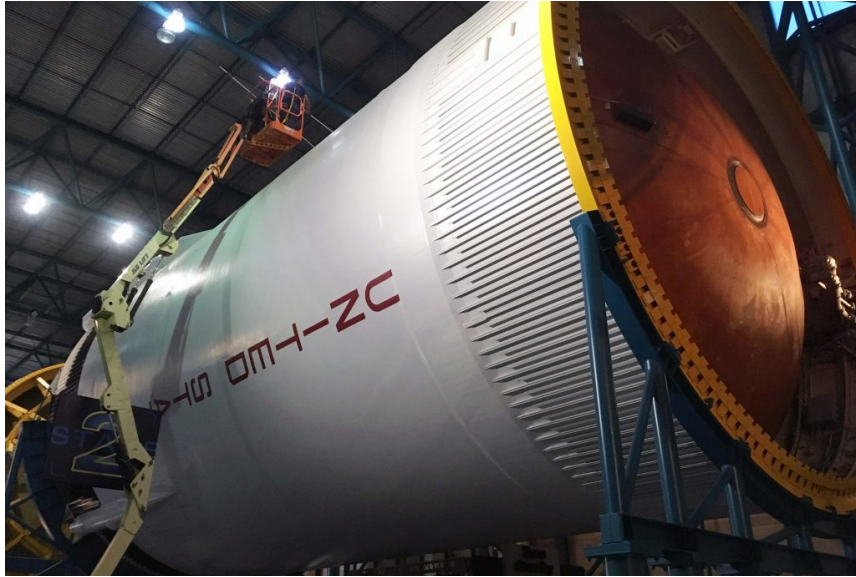
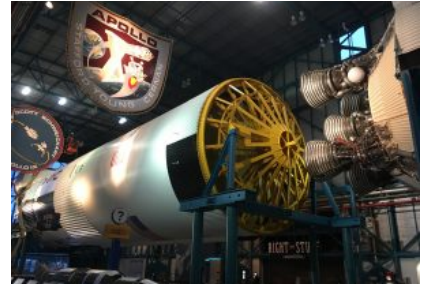
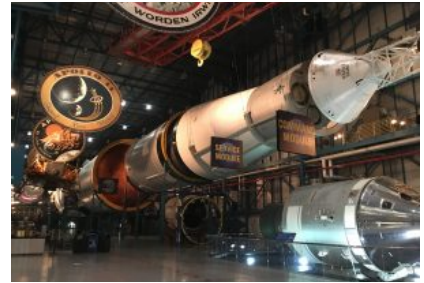
While the moon rocket had been relatively well-preserved in this environment-controlled facility, heavy dust and debris had slowly collected on the apparatus. Furthermore, corrosion had developed around the thrust chambers and extension nozzles of the engines. Finally, a significant structural fracture existed at one of two gimbal strut actuator attachment points (clevis). These struts collectively support the J-2 engine on S-II (second) stage of the craft.

Our conservators carried out the cleaning, mitigation of corrosion, and repair of the fractured clevis. Using aerial boom lifts to access the rocket, the team employed both wet and dry cleaning methods. Chloride residue, identified by Conservation Solutions during their earlier assessment, necessitated the use of a vapor phase corrosion inhibitor at the sites of corrosion. The stabilization of the clevis was achieved with the addition of two steel plates to immobilize it.
