Saturn V Rocket Conservation

JOHNSON SPACE CENTER, HOUSTON, TX

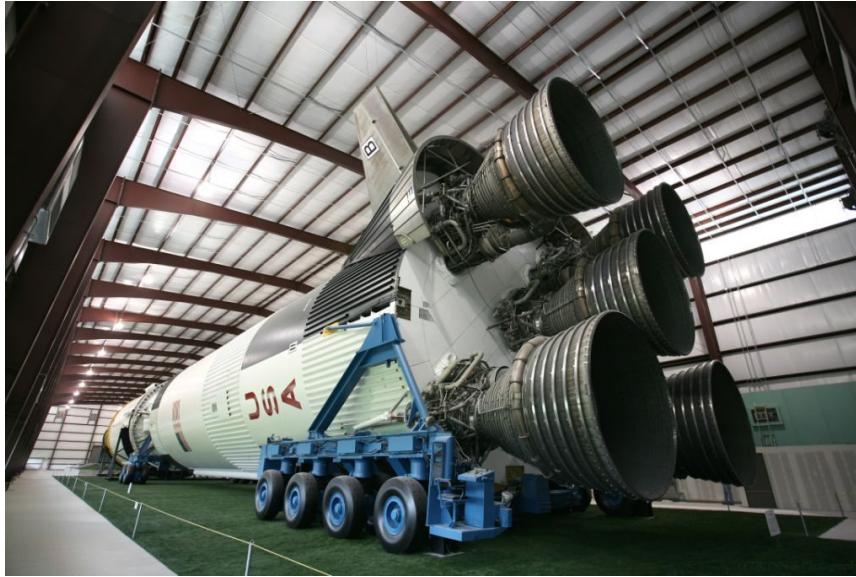
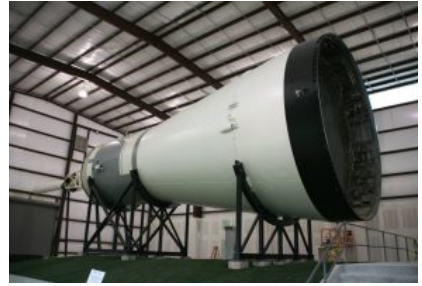
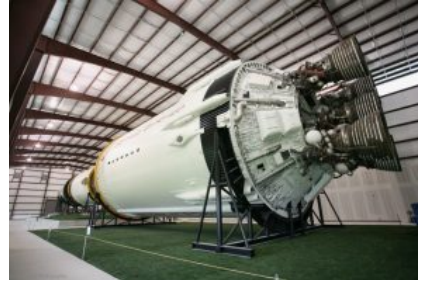
From 2004 to 2006 we stabilized and restored the Saturn V Rocket located at the Johnson Space Center in Houston, TX. This example is one of three surviving vehicles built during the late 1960s to launch Americans to the moon, and is assembled from flight-ready stages and spacecraft from the Apollo and Skylab programs. Measuring 363-feet-long and capable of generating 7.5 million pounds of thrust, the Saturn V remains the largest, most powerful American launch vehicle ever built. Displayed outdoors since 1977, the rocket exhibited widespread paint failure, moisture infiltration, structural failures, an overall accumulation of atmospheric and biological soiling, and severe corrosion of its complex system of metal alloys, including aluminum (extruded, cast and milled) and aluminum honeycomb sandwich. Non-metal materials such as spray-on polyurethane foam, cork, and various types of plastic, phenolic resin, and fiberglass composites, had significantly deteriorated.

We previously performed a condition assessment and material analysis/testing to inform their recommendations for appropriate conservation treatment. General treatment included the removal of debris using high pressure waterjets (>25,000psig), with more fragile materials being stripped of coatings using chemical gels. Corrosion was treated and metal failures were repaired in-kind. Structural repairs were designed by engineers and installed to return structural stability to significant features. Modified and new display stands components were designed for the Service Module and Command Module/Launch Escape System. After all repairs were complete, the rocket was primed and painted to match the historical color and scheme determined through paint analysis. Matching decals were custom made and installed over the paint system.
