Soldier at Picket Restoration

SARATOGA SPRINGS, NY

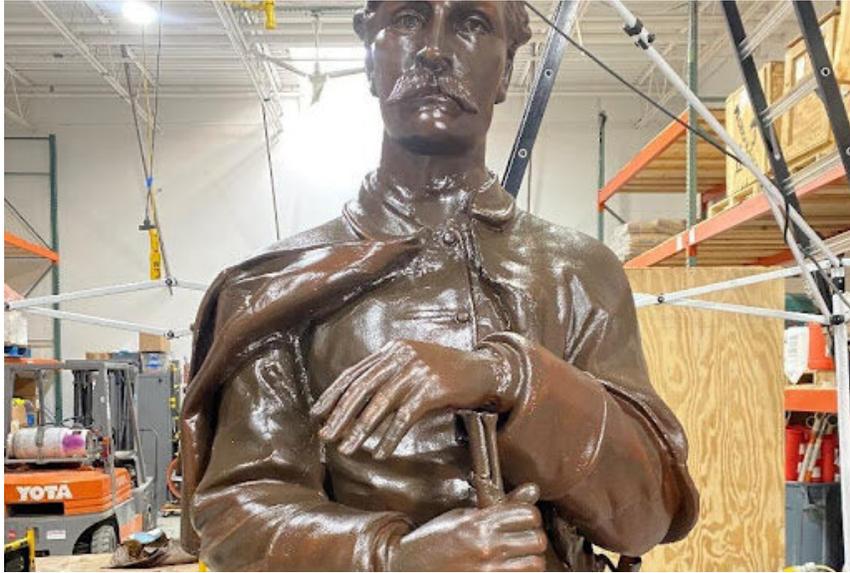
Like many towns throughout America, Saratoga Springs erected a monument in Congress Park to the city's sons who fought for the Union during the Civil War. The zinc statue depicts a private on picket, one of the tributes to the sacrifices of the simple soldier rather than solely the Generals and statesmen that were erected in the late 19th century by both sides of the conflict. This model was made by the J.W. Fiske Company of Brooklyn NY and was one of many of the same statues they created. During the spate of statue destruction in early 2020 the life-sized figure in Saratoga Springs was toppled from its high pedestal and shattered into many pieces, some as small as an inch across. City employees collected all of the pieces but despaired about the possibility of restoring this point of civic pride and history until they found us. EverGreene conservators are experts in the restoration of zinc statuary, having restored dozens of other works and two other versions of this same statue in [Canton, MA](#) and [Oak Bluff, MA](#).

The fragments were transported to our DC Studio for the restoration. Each part was cleaned to remove soiling and paint. Working from the bottom, sections were carefully soldered back together along original seams or new breaks. It was a process akin to a three-dimensional jigsaw puzzle, where small and obscure pieces were tried against each other until their locations were determined and they could be re-attached. Several elements were missing, including the gun strap, a thumb, and some other pieces that were not recovered. Other elements were too severely deformed and had to be recreated. Simple losses were fabricated by our artisans from sheet zinc. Complex pieces were replicated by making a wood or foam mold and were then cast in a foundry.

A stainless steel armature was introduced to the statue to support the re-assembled figure and provide resistance to future possible vandalism. After fully rebuilding the figure and fairing the joints, it was re-painted in a faux bronze finish. This technique creates the appearance of a brown patinated bronze and was used on this work originally. The finished piece was crated, returned to the site, and re-erected on its original base in November 2021.
