Sutri Fountain

VIZCAYA MUSEUM AND GARDENS, MIAMI, FL

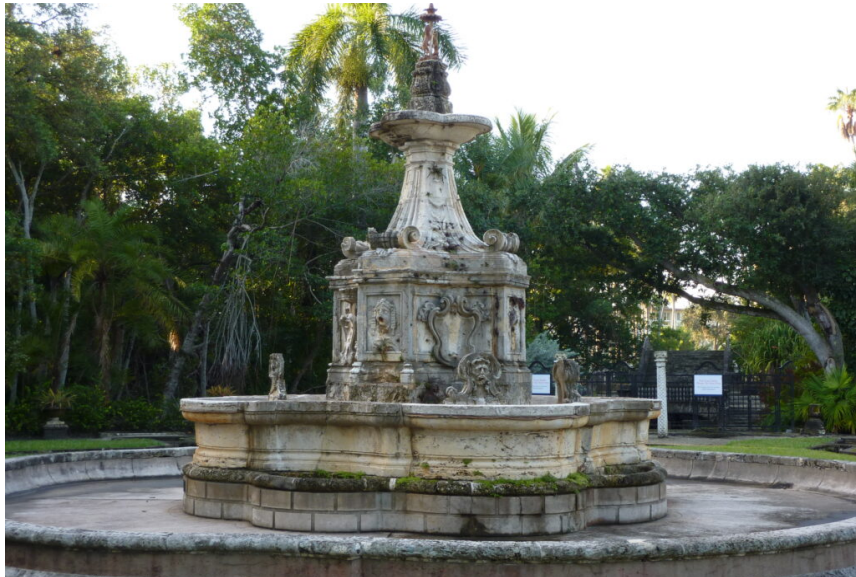
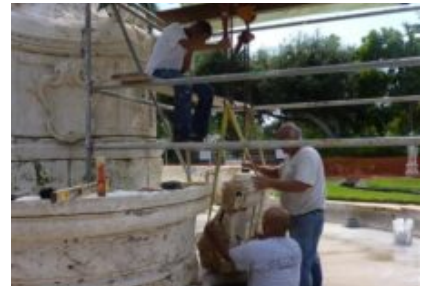
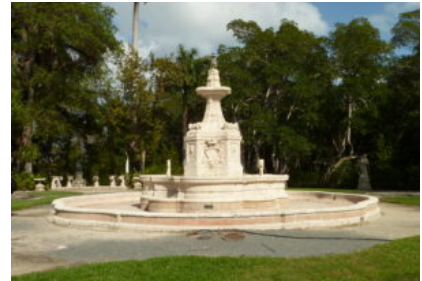
The fountain was plagued by various types of biological soiling and mineral staining due to lack of water filtration, as well as erosion from years of operation. It had also been subjected to several inappropriate repair campaigns. Cracks in the basin walls and basin floor raised serious structural concerns, threatening the continued operation of the fountain.

We were tasked to carry out an assessment and treatment of the Sutri Fountain during the course of a multi-year restoration project. Cleaning followed by further investigation and testing to develop appropriate protocols for deeply embedded mineral stains were the initial steps. Repairs included stone patching, new travertine dutchmen, crack injection and internal pinning to repair broken components. The final scope required engineering to identify a strategy to repair the primary fountain basin. The project also required: dismantling the basin walls; demolition of the existing basin floor slab; routing of new chaseways for infrastructure; replacement of coral stone moldings and pinning and reinstallation of the basin walls.
