University Of Virginia Campus Art

UNIVERSITY OF VIRGINIA, CHARLOTTESVILLE, VA

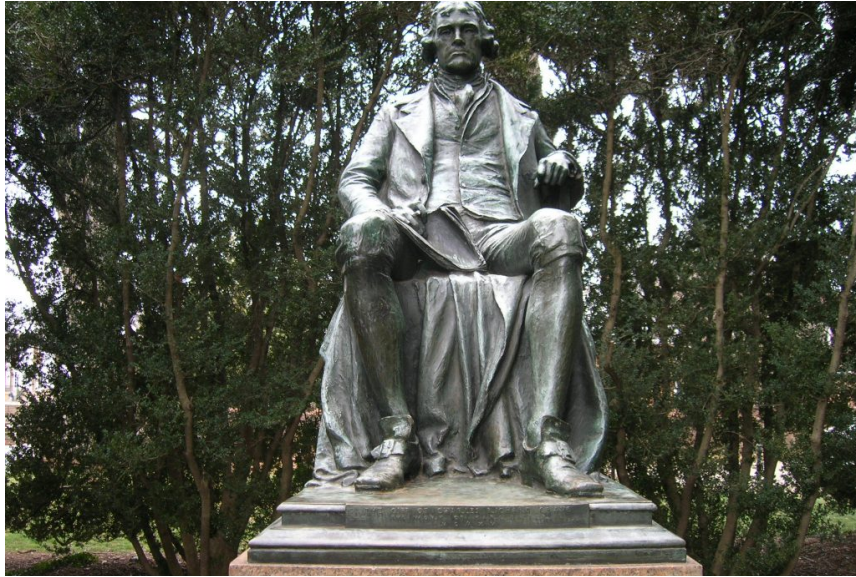
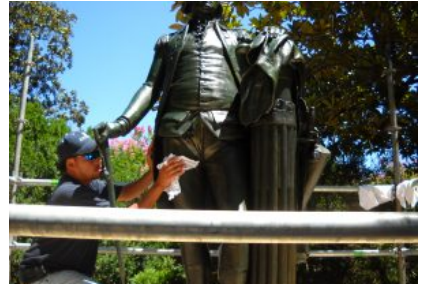
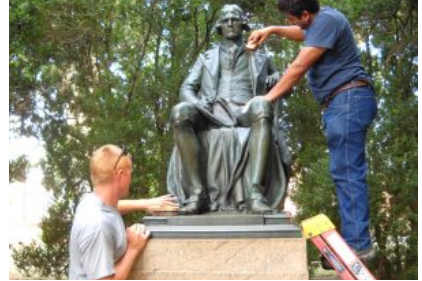
We were contracted to perform the condition assessment and subsequent treatment of all bronze sculptures on the campus of the University of Virginia. Work occurred during several campaigns. Losses in the bronze were replaced, breaks in assemblies were repaired and dutchman and patching repairs were performed on the stone bases. The works were washed and custom formulated National Park Service wax was applied to heated surfaces with an additional harder paste wax to provide a level of protection against the environment. Lead caulking was applied to Jefferson and the excess lead was removed. Micro-air abrasion, undertaken at the lowest effective setting, removed the black soiling from Washington's base.
