## U.S. Holocaust Memorial Museum Limestone

WASHINGTON, DC

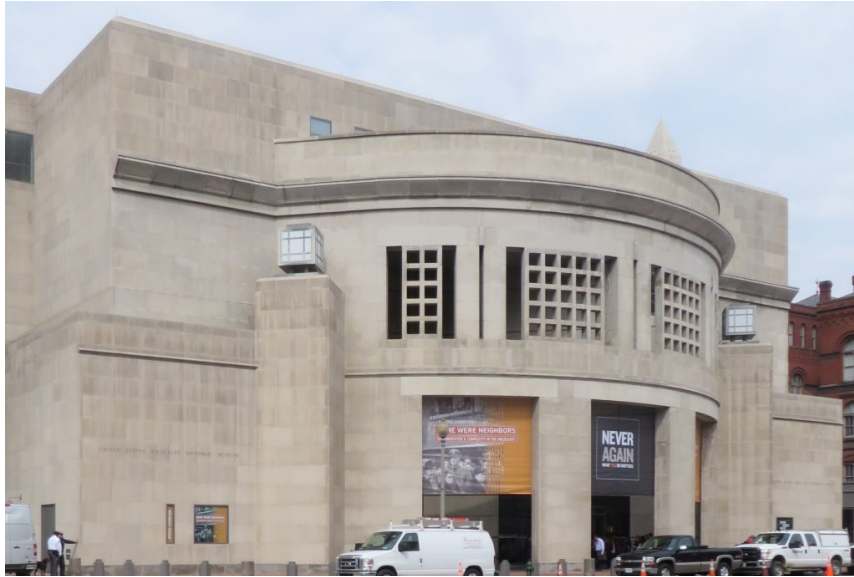
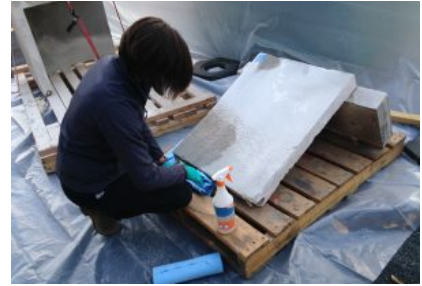
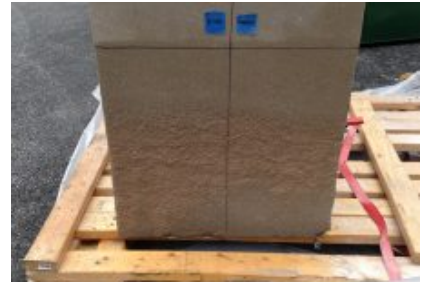
The US Holocaust Memorial Museum opened in April 1993 in Washington D. C. In recent years certain areas of the limestone cladding of the museum began exhibiting substantial deterioration. Stone panels were losing surface and substantially eroding in unexpected locations where the cause was not obvious to determine. Studies focussed on understanding the movement of moisture and air within and around the cladding, back up wall and interior as well as possible remediation of the stone itself.

We were contracted by the Architrave P. C. Architects to conduct testing on the limestone panels to determine if the panels could be restored once the root causes driving the deterioration were remedied. The tests included limestone consolidation, water repellent coatings, patching and resurfacing. Sample panels were prepared and subjected to accelerated weathering, monitoring, and laboratory analysis. Patching and resurfacing treatment were mocked up and observed over an extended period. The findings were documented and included in a testing report that was incorporated in the Architect's recommendations to the Client.
