Source: *APT Bulletin: The Journal of Preservation Technology*, Vol. 43, No. 4, SPECIAL ISSUE ON IRON AND STEEL (2012), pp. 41-50

# Conservation of the RMS *Titanic* “Big Piece”: A Case Study and Critical Evaluation

**The salvage and treatment of a significant section of the *Titanic* illustrate the great logistical and technological challenges associated with the conservation of a monumental iron artifact recovered from a marine environment.**

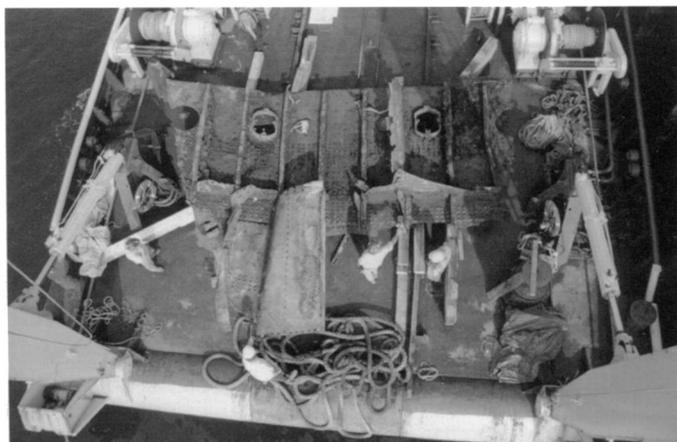
Fig. 3. The Big Piece shortly after it emerged from the sea aboard the recovery ship, 1998.

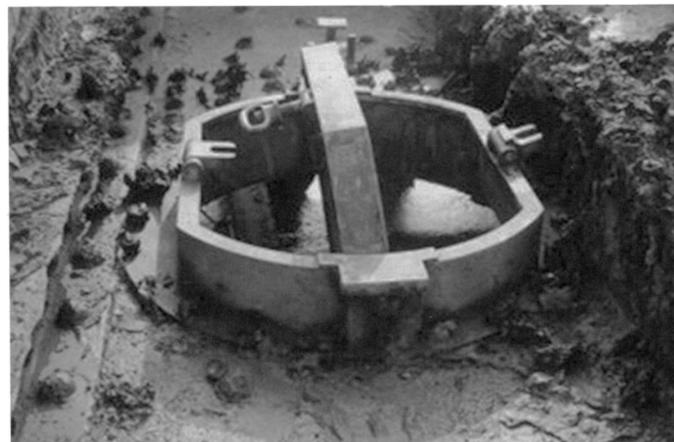
Fig. 4. A surviving bronze porthole and rusticles, which remained intact on the surface of the Big Piece, shortly following recovery, Boston, Mass., 1998.

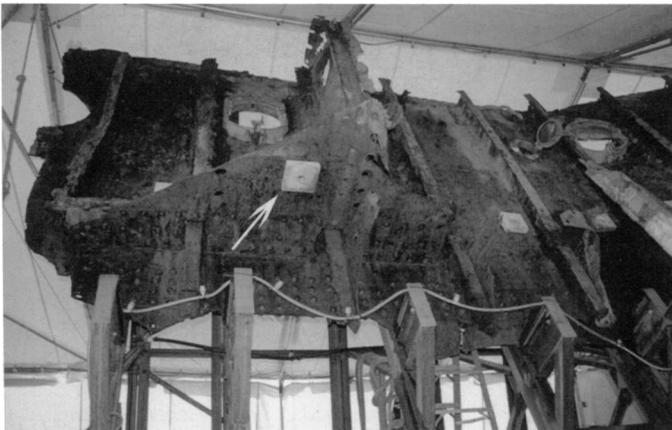
The installation of sacrificial anodes is a low-impact treatment meant to arrest ongoing corrosion of an artifact, either in situ or during passive soaking (Fig. 5). To that end, a more highly reactive piece of metal (anode) is attached to the artifact (cathode), in the presence of an electrolyte. In situ, the electrolyte is seawater itself; in passive soaking, the electrolyte is typically sodium carbonate. In this system, the anode deteriorates preferentially, thereby providing protection to the artifact.

Fig. 5. Sacrificial anodes (indicated by arrow) attached to the Big Piece to help facilitate the extraction of chlorides during the soaking process of the compromised artifact, Boston, Mass., 1998.

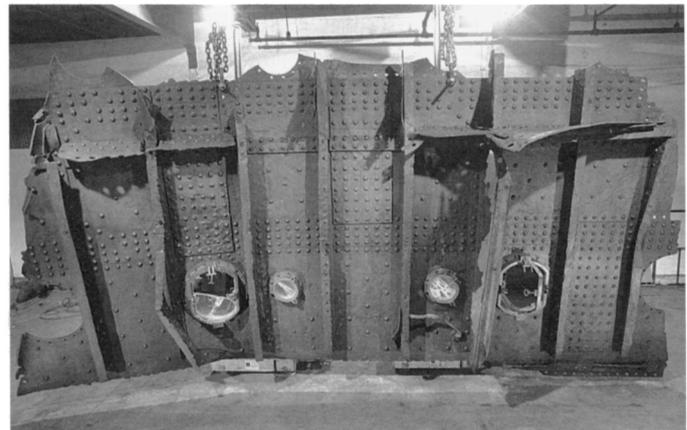
Fig. 6. The interior of the Big Piece, following completion of initial treatment in 2000, Front Royal, Va.

port and display. Iron stains on the glass were removed or reduced using multiple applications of a 3-5 percent solution of ethylene diamine tetraacetic acid (also known as EDTA).<sup>28</sup> All metal surfaces were treated with a protective barrier coating of thermally applied microcrystalline wax. Once the metal cooled, the waxed surfaces were polished using Tampico natural-needle buffing wheels fitted on an electric drill (Fig. 6).

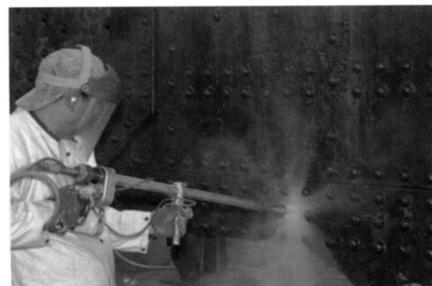
Fig. 8. Ultra-high-pressure water-jetting being performed on the Big Piece, Houston, Tex., July 2004. Courtesy of Steve Dunne.

Ultra-high-pressure (UHP) water-jetting was considered because of its ability both to offer controlled removal of rusticle crusts and to mobilize and remove soluble chlorides (Fig. 8). UHP emerged as an industry standard for metal-surface preparation in the second half of the twentieth century. UHP water-jetting technology consists of highly specialized pumps, hoses, nozzles, and accessories necessary to create and deliver water at a pressure up to 35,000 psig.<sup>29</sup> Pressurized water has two working components: direct impact (shear force) or erosion effect, which is controlled principally by the pressure of the stream, and hydraulic or lifting effect, which is controlled principally by the volume of the stream.

The conservators partnered with a team of industrial-corrosion professionals to quantify the concentration of salts on the surface and to develop a proper cleaning methodology that could be safely used to achieve the intended goals. Through testing mock-ups, it was determined that the hull could be cleaned using waterjets at 10,000-20,000 psig, depending upon the thickness of the crusts to be removed. Utilizing a rotating nozzle at a standard surface-to-tip distance of 2 to 4 inches, the high-pressure water rapidly and safely removed crusts and crust residue and unstable corrosion products. It also flushed pores, cracks, and interstices between plates with heated, filtered water. Specialty tips were utilized to introduce pressurized water into tight spaces and between plates.
