OUTSIDE THE CANON: A REVIEW OF UNIQUE APPROACHES TO STONE CONSERVATION

Justine Posluszny Bello,¹ Daniel Lane,¹ Mark Rabinowitz,¹ Joseph Sembrat¹,

¹ *Conservation Solutions, Inc.*

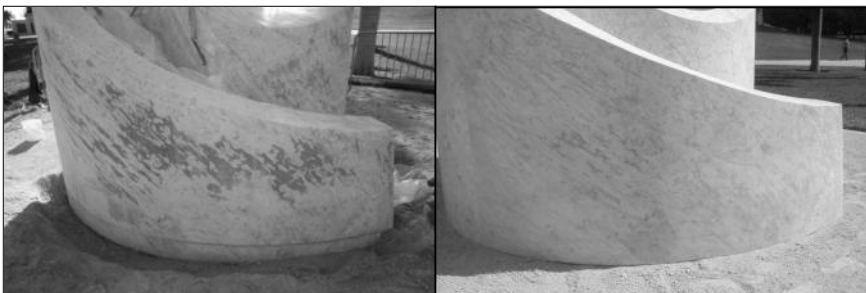
Figures 1, 2. Disfiguring biological staining before (left) and after (right) treatment with CB-4 bacteriostatic detergent.

Uniquet CB-4 is a bacteriostatic detergent that penetrates microbiologically influenced biofilms. Although initially developed for the purification of water wells, consultations with the manufacturer suggested that this cleaner could be effective in removing tenacious biological soiling in and on stone surfaces as well. The action of the detergent leads to three major impacts: (1) the breaking apart and dispersion of the biofilms; (2) the destruction of the microbial cells particularly when the concentrations applied exceed 0.5%; and (3) dispersing attached materials formed by the infestation and growth of microorganisms associated with the biofilms. In general these impacts on the entrenched biofilms on surfaces require sufficient retention times to allow each of the three events listed above to be completed in the appropriate sequence. In water wells and pipelines the retention times vary but the ideal should be 12 to 24 hours for each stage. This allows enough time for the CB-4 to effectively disperse the infesting biofilm and associated concretious chemical accumulates; effectively reduce the active cells by at least three orders of magnitude; and then disperse attached materials from within underpinning surfaces (e.g. eroded pores into the marble).

The material was tested in sequence with other common detergents and quaternary biocides. Cleaning was effected first with a surfactant (Triton X-100, 3% solution) then a quaternary biocide (D/2 Biological Solution, 50% solution) followed by applications of CB-4 (5% solution, paper poultice, wrapped in plastic sheeting for a 24-hour dwell time). It is believed that the detergent removes surface soiling and exposes the biofilm. D/2 penetrates and disrupts the biofilm and biomass. The CB-4 acts as a penetrating biocide which attacks the structures formed on and beneath stone surfaces. These structures then collapse and can be easily removed by light scrubbing/ rinsing. This combined technique was used successfully to significantly reduce red-orange microbiological staining on the white marble sculpture *Slide Mantra* (Isamu Noguchi; Miami, FL), previously thought to be an intractable problem (Konkol et al, 2009). The authors have also used this method selectively on the New York Public Library Lions and elsewhere.

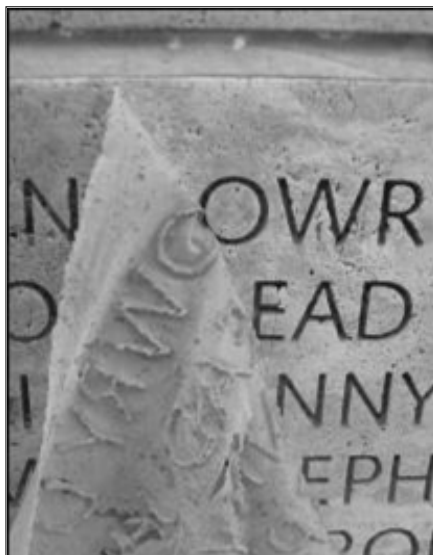
Figure 3. Prestor gel being pulled from the surface of the National Law Enforcement Officers Memorial, Washington, DC.

Both the effective killing through prolonged contact of the biocide with the biota, and the removal of the killed infestations within the pits, were problematic and necessary to the treatment goals (Rabinowitz et al, 2011). This was achieved by modifying the process through the use of Prestor Gel (CBI Polymers, Honolulu, Hawaii, USA) as the transmission agent for CB-4 as a replacement for the paper poultice. The product, based on a material developed to decontaminate nuclear sites, is a polymeric gel that has the capacity to wick into microscopic pores. Unlike other commercially available gel-cleaners, which are typically latex rubber-based and polymerize into an elastic film, Prestor is water-based and water-soluble, and offers much greater mechanical cleaning ability through its tenacious cling to and pull from the surface. It readily clings to vertical and overhead surfaces, although its relatively low viscosity necessitates careful site protection and application methods. As it dries, it shrinks approximately 20% and forms a tough, pliable skin that encapsulates anything contained within it. After approximately 24 hours, depending on environmental site conditions, the gel can be peeled away and disposed. This period corresponds to the necessary dwell time for the CB-4, meaning that it can be used to both ensure the CB-4 has sufficient contact time to effectively act upon the bio-colonies as well as remove them afterward, potentially reducing re-soiling rates. One year after treatment the stone of the Memorial remains unsoiled, confirming this effect. Please note that the tenacious pull of the gel is not appropriate for friable substrates and should only be used on sound, dense stones.

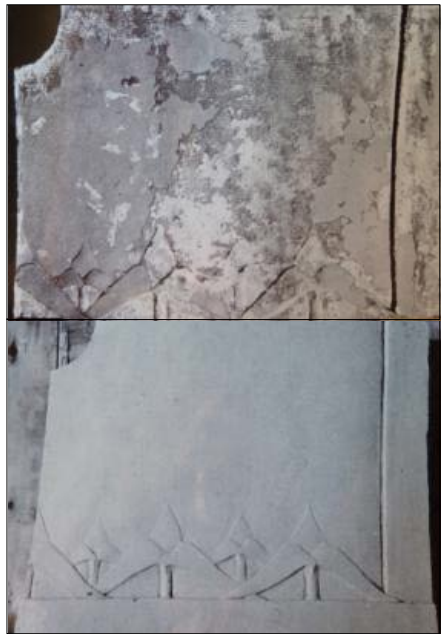
Figures 4, 5. Panel encrusted with calcium and magnesium deposits before treatment (above) and after successful ultrasonic cleaning (below).

jewelry, industrial equipment and sensitive electronics. The authors have also experimented with expanding this technology for use in the cleaning of masonry materials, including limestone and terra cotta. Ultrasonic cleaning is necessarily limited by the size of a vessel that can contain the object to be cleaned; it also requires a significant investment in equipment (transducers). Despite these potential hurdles, the authors saw an opportunity for ultrasonic cleaning of terra cotta and limestone elements from the Four Seasons Fountain in Ames, Iowa. At this site, the decorative fountain elements had been marred by an accumulation of iron stains and calcium carbonate deposits due to hard water and deterioration of the internal plumbing system. Typically, stains and deposits of this nature might be broken down through the use of strong oxidizing acids, or mechanical means such as abrasive blasting. These methods, while effective, can also render permanent damage to the underlying surfaces. Ultrasonic cleaning was explored as

a way to effectively reducing this soiling without introducing damage to the substrate. Through a sequence of testing using different ultrasonic frequencies, water temperatures, and cleaning agents, parameters for treatment were established. It was determined that frequencies in the range of 38-42 KHZ afforded effective but not overly aggressive cleaning, aided by Branson OR, a proprietary, citric acid-based cleaning solution. Water temperature was maintained at 150°F and a pH of 4-4.2. Each element was situated in the custom-built ultrasonic tank and cleaned for successive 1-hour intervals, which typically totaled 6-8 hours of treatment overall. After cleaning, the element was transferred to a rinsing bath of deionized water. The net findings were that the ultrasonic cleaning was highly successful at effectively cleaning terra cotta surfaces without damaging the substrate, however, this cleaning method was not initially successful at reducing the same deposits on the softer, more delicate limestone (Sembrat, 1998). Additional research will be needed to evaluate appropriate ultrasonic frequencies, duration of cleaning cycles, and cleaning agents to effectively clean limestone and other historic materials. It is possible that some modification of the system may allow for more localized treatments, increasing its effectiveness.

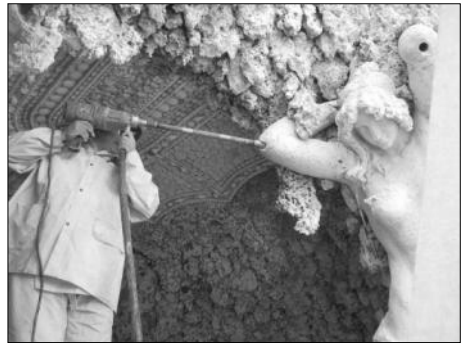
Figure 6 (above). Core drilling a sculpture to facilitate installation of a grouted anchor.

Grouted anchor systems, in a variety of proprietary iterations, have been used over for more than 20 years to effectively stabilize historic masonry structures by “stitching” together unstable walls, particularly those with internal voids or poorly bonded courses. Due to concerns about the use of synthetic adhesives for bedding anchors, the authors have also successfully extended this technology to the internal stabilization of compromised stone sculptures. The goal is to replace the epoxy binder with grouts whose thermal expansion and moisture transmission characteristics are closer to those of stone. For installations other than vertical cores that are accessible from the top,

this process requires bedding the stainless steel anchor within a polyester fabric sleeve, then inflating it by injecting a cementitious grout under low pressure. The sleeve expands with grout to fill the hole as the fabric is inflated. Some grout leaches through the fabric, which allows the paste to adhere to the core walls while containing the aggregates within the sock. With the sleeve’s flexibility, it is able to mold into the voids and spaces within the sculptures, allowing it to be used to pin and reassemble fragments while minimizing or excluding the use of epoxy. The sock also allows for installation in conditions that would not otherwise be feasible, such as horizontal or upward cores, where grout would simply run out of the holes if not contained (Cintec, 2012). The system has been used to pin stones on the Barnard Statuary Groups at the Pennsylvania State Capitol (Harrisburg, PA); the Tripoli Monument at the US Naval Academy (Annapolis, MD); cast stone reliefs by artist Constantine Nivola at Yale University

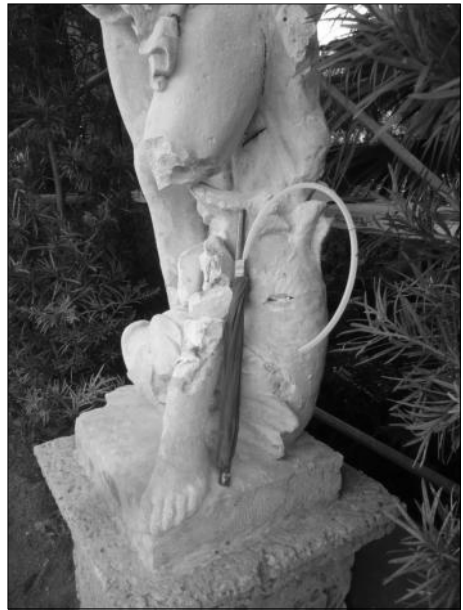
Figure 7 (below): A grouted anchor system prior to installation.

The flow capacity of the grout and its ability to remain viscous and not separate during installation are essential characteristics. Presstec grout used as part of the Cintec system is the only grout the authors have found with these characteristics. Where there have been concerns about possible differential compressive strength or when used to repair narrow stone units, such as in the repair of the pedestal supporting a basin within a marble fountain at Kykuit in Tarrytown, NY, narrow closed-cell foam backer rods have been inserted into the holes parallel with the anchors to act as bond breakers and to allow for and absorb some expansion, minimizing stress on the surrounding stone.

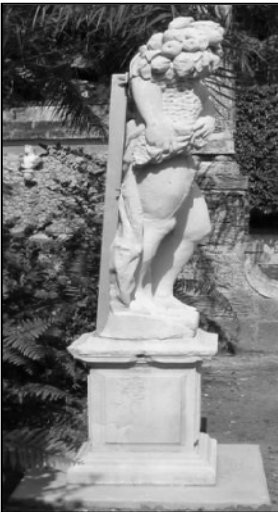
Figure 8 (left). Example of a strongback mounted to the sculpture of *Pomona*, an example of a sound sculpture secured to a new concrete footing.

A strongback for a sound sculpture with an adequate footing and mounting consists of a solid stainless steel bar, approximately the height of the figure, mounted vertically behind the sculpture, generally following the profile of the base and sculpture, which is

set into a reinforced concrete footing. The bar is connected to the figure with several strategically placed reinforcement points, located at or above the mid-section and middle-upper back. Neoprene pads may be set between flanges on the bar and the stone sculpture to provide cushioning. Ensuring the rigidity of the post allows for use of a rigid mounting bolted to the sculpture. For example, the sculpture of *Pomona* located at Vizcaya Museum & Gardens features a strongback that was welded to an internal grouted anchor which continued

through the base of the sculpture and was embedded in a newly poured concrete footer upon which the entire sculpture assembly was positioned. Due to the frequency with which the authors have had to implement this kind of support in the Miami, FL area, they have worked with a structural engineer to develop a design which has been engineered to withstand the Florida Building Code requirements for high velocity hurricane winds. The system presumes that the sculpture is itself well-supported.

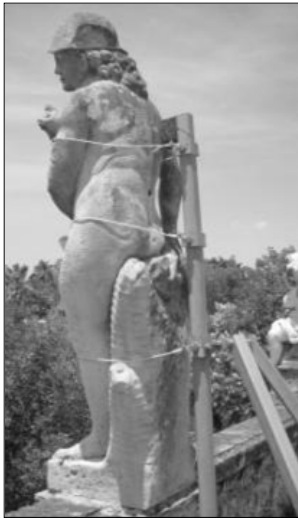
Figure 9 (right): Example of a low-impact strongback in which nylon-coated stainless steel cables were used to secure a sculpture on a roof parapet.

An alternate design has been used in situations where it is not possible to confirm that a sculpture is soundly mounted. To avoid excess loading at bolt points when some movement may be encountered from high winds, a similar bar is used but it is only attached to the sculpture with surrounding cables. Coated aircraft grade stainless steel cable is looped around the figure at several locations and connected to flanges on the vertical bar. On a roof top, this bar is also braced with diagonal supports, all bolted to the roof deck and waterproofed. The cables are kept snug against the figure but not overly tightened. The cable shield consists of semi-transparent nylon, which can be painted if needed to blend with the sculpture. This design is intended to support the sculpture against catastrophic loss in a severe wind event while allowing for some rocking or movement. It has proved effective on parapet figures, where some evidence of rubbing of the cables against the stone five years after installation demonstrates that movement has occurred. Ideally, the work should be hoisted and securely pinned as well as provided with a strongback if needed but, in situations where this is not feasible, this method may be used. In conditions where previous strongback installations have already failed, leaving weakened and cracked stones that cannot safely be pinned unobtrusively, it may be the best available method to prevent disastrous loss and limit threats to persons and property. It can also be used for short term stabilization for life/safety concerns pending more thorough restoration. A disadvantage of this strongback is its higher visual intrusiveness than one solely mounted to the back, which is a greater concern for sculptures at ground level than those atop buildings. However, a well-thought out design, discreet placement of the reinforcing cables, and coating the bar and cables with a sympathetic color of paint, can minimize the visual impact while still lending adequate support to the figure.

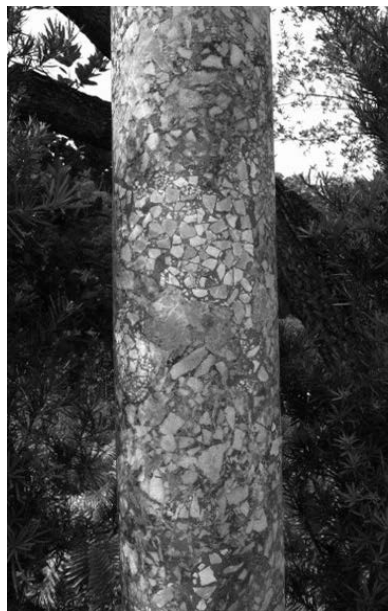
Figure 10. Example of a sample stone mosaic repair held in front of the host stone for comparison.

Major losses on brecciated marble columns at Vizcaya Museum & Gardens were rebuilt either by creating a terrazzo-like patch or creating a mosaic matrix. On the mosaic patches, a variety of stones comparable to the range exhibited in the existing column were selected and broken or cut to create tesserae that matched the shapes in the original stone. Once the void was properly cleared and prepared for repair, a colour-matched acrylic-modified grout was laid into the void to serve as a bedding mortar and the stone tesserae were set in it slightly proud of the profile to approximate the colour, veining, and texture of the natural stone. Joints were grouted with the same mortar used in the bedding. Once the grout was set, the entire patch area was honed down using a wet-polisher equipped with a 50-grit diamond bit pad. Care was taken to ensure the patch repair was shaped to match the round profile of the column. Final dressing of the patch was done using sequentially finer pads up to 2000-grit. Care was taken to ensure adjacent surfaces of the column were not abraded during this process. Any minor losses of tesserae or voids in the grout were filled with additional material and screeded flush.
