Modern Surgery and Anesthesia

Alfred Crimi | 1936

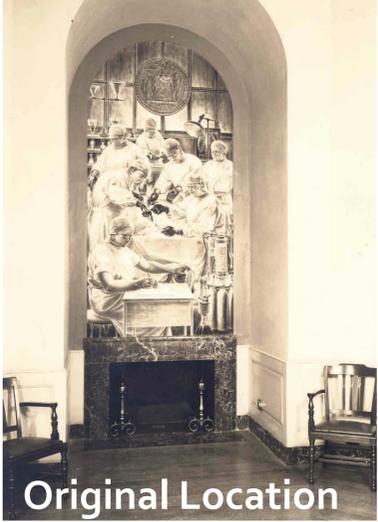
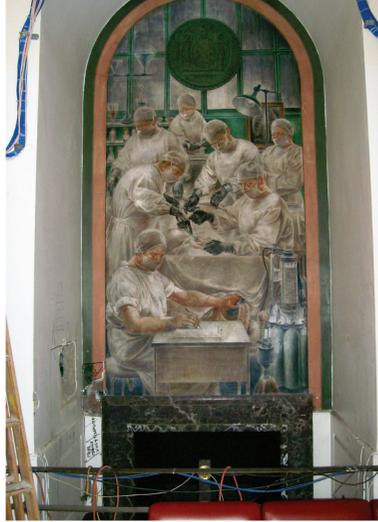
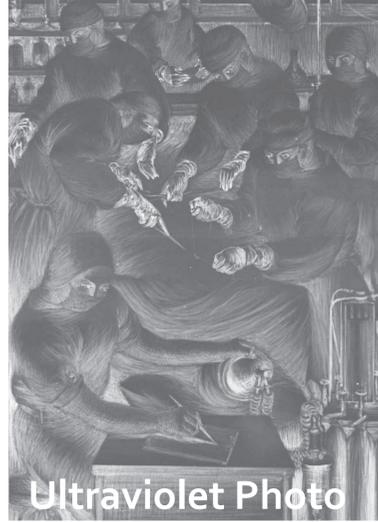
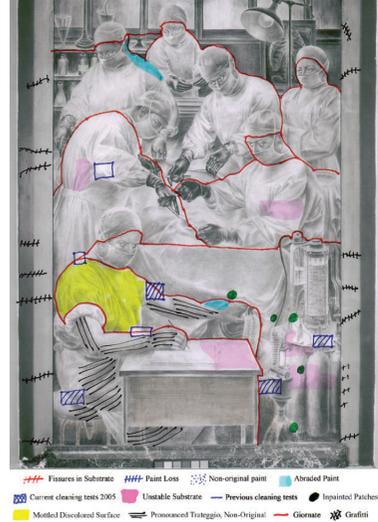
Survey

The initial conservation study revealed paint loss, cracks in the plaster, unstable substrate, and discolored areas.

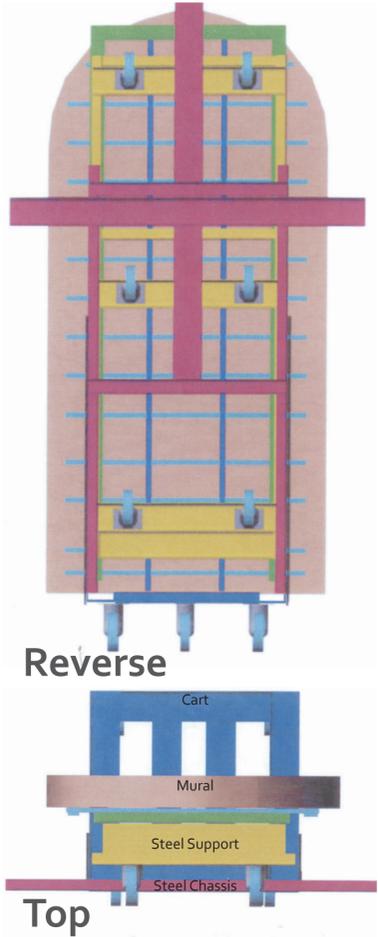
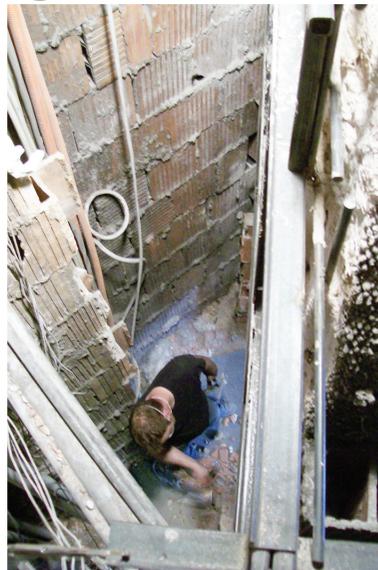
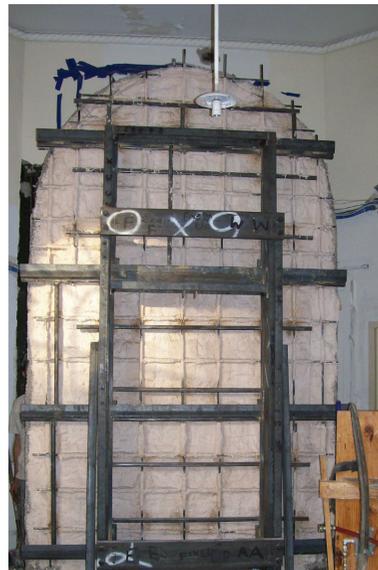
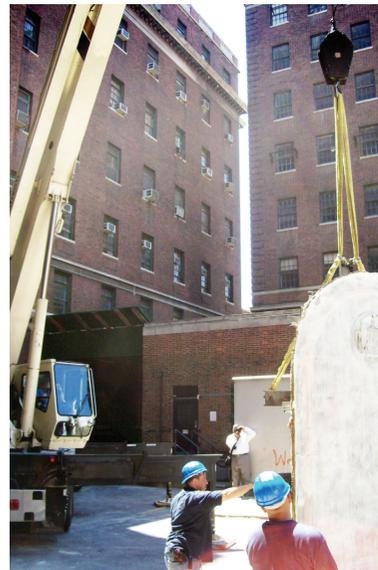
Removal & Storage

The location of the mural in the previous building posed new challenges for its removal. To remove the mural, conservators constructed a steel support system in a very narrow airshaft behind the mural. Once the steel structure was in place, and securely attached to the rear of the fresco, the mural was cut free, lowered, and rolled out of the building through an opening cut out of the wall.

Prior to relocation, conservators applied a thick coat of a wax-like substance that—once dry—evaporates directly from a solid to a gas when exposed to oxygen. The mural was then wrapped in plastic to preserve the coating during transportation and storage.

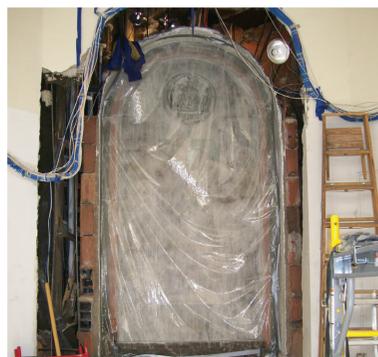
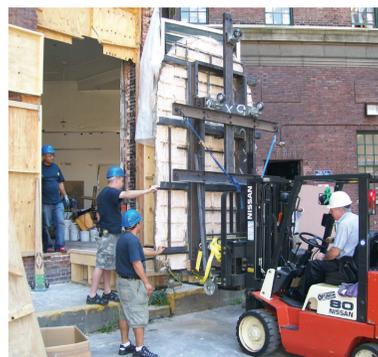
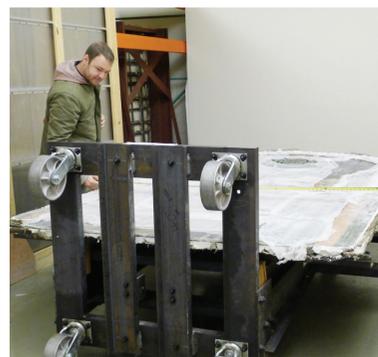
A team of art movers, using a forklift and a crane, extracted the heavy mural from the building, and the fresco was taken to a climate controlled storage facility, where it was stored horizontally for stability. By a process known as consolidation, adhesive was injected into the cracks to stabilize fragile substrate and edges.

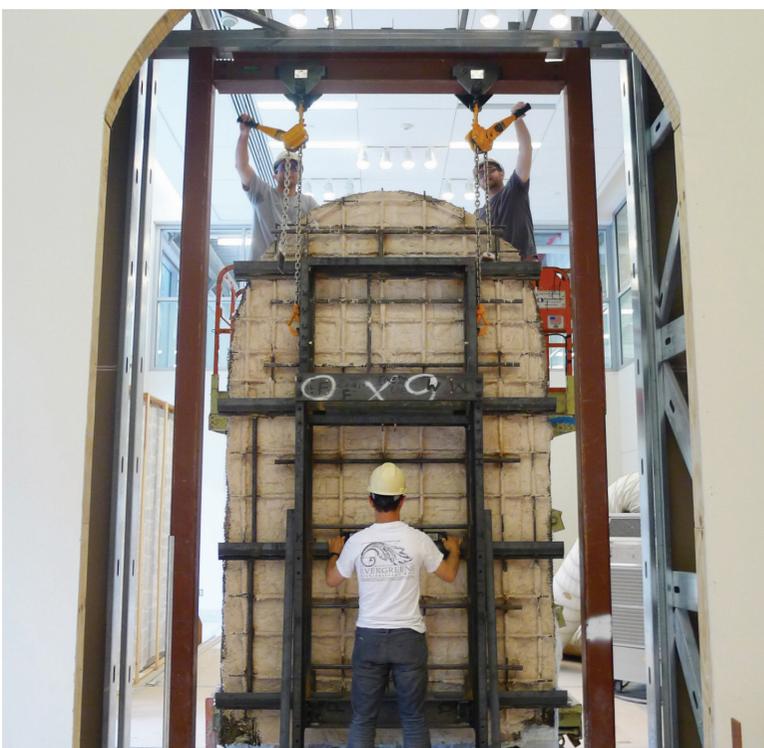
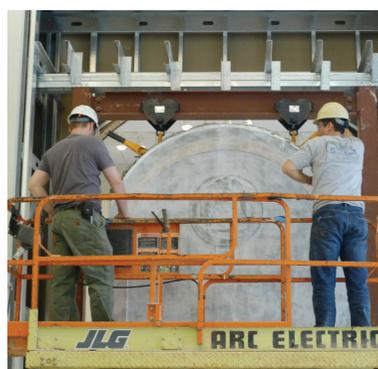
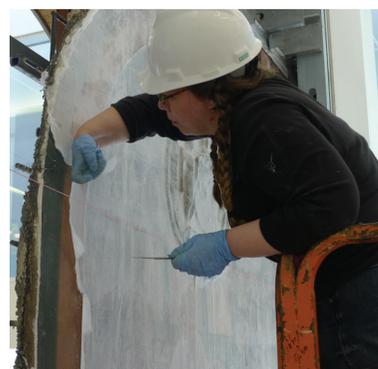
Installation

The custom built steel support installed on the reverse of the mural was hoisted from the ground to the concealed support beams and cranked into place with locking jacks. The wall was then built flush around the fresco.

Once in place, the plastic wrap was removed and the protective coating was able to sublimate naturally without disturbing the face of the mural.
